# REPORT ON THE 1999 SEASON AT KERKENES DAĞ

Musa Özcan, Dursun Çağlar, Geoffrey D. Summers,  
Françoise Summers and David Stronach<sup>1</sup>

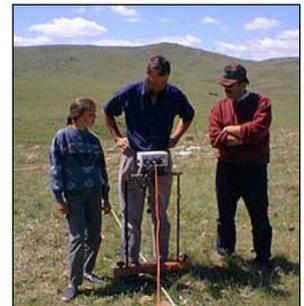
*Electrical resistance survey*

Experiments with electrical resistance survey were carried out in the spring season and in the early part of the summer season. The aims were to see if this method would locate features not visible on the magnetometer images, particularly stone column bases. The columned hall in Area B was selected because excavation in 1996 had confirmed the existence of stone bases. It is also anticipated that resistivity survey will indicate different types of surface and flooring, and may make possible the construction of pseudo-sections. Equipment problems in the spring and exceptional dryness in the early summer meant that results were inconclusive. It is intended to make an application for a permit that will allow new trials in the spring of 2000.

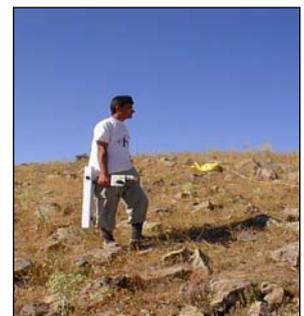
*Geomagnetic survey*

Geomagnetic survey with a GEOSCAN fluxgate gradiometer covered 20 x 20 m. grids, a total area of 52800 m<sup>2</sup> (**Fig. 2**). Young men from Şahmuratlı Köy have been trained to collect and download data, undertake preliminary processing and print out daily results. By working 2 shifts per day it has been possible to collect data from up to 40 grids per day. The use of a pre-release version of GEPLIT has facilitated processing and printing of composite images despite initial teething problems of hardware incompatibility.

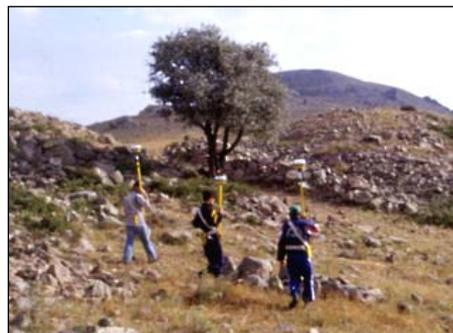
*GPS mapping of surface topography*

GPS mapping of surface topography with one base station and three roving receivers continued in 1999 (**Figs 1 & 8**). The resulting image now covers some 80% of the city and is generated from a total of 1,286,767 data points of which 886,377 were collected in the 1999 season. Accuracy is to within 10 cm.

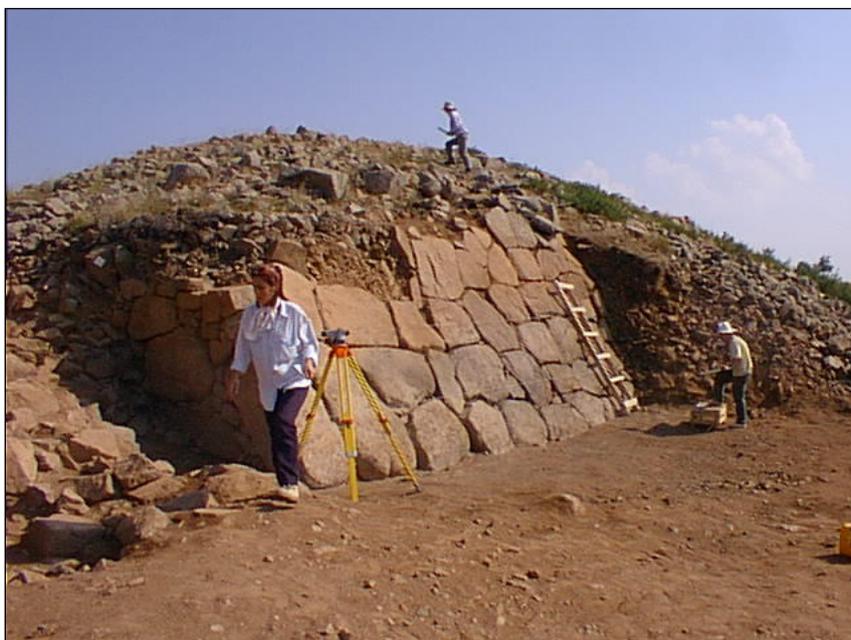
*Glaciis of the South-East Tower of the Cappadocia Gate.*

To the west of the Gate the clearance revealed a continuous stone glacis face that enveloped the S.W. Tower of the Gate, a short (8 m) E-W stretch of wall, a long (24 m) N-S- stretch of wall, and exposed the north end of a protruding buttress (Buttress 1). To our surprise, the tall exposed glacis face of the two adjoining stretches of wall proved to have survived up to 5 to 6 m in height with an inclination of 60°. In places the glacis face appears to have survived to within a course or two of its original height. To the east of the Gate the glacis on the south face of the S.E. Tower was followed for a distance of at least 6 m. Here the glacis reached a maximum height of 4 m with a relatively steep inclination of *c.* 80°.

As far as the construction of these various stretches of glacis are concerned, they appear to have been erected on a natural bed of red gritty clay which may well have been levelled to form an even base. The facing stones of the glacis are unusually large (up to 1.5 m in height), but they are nevertheless skilfully arranged in a kind of cyclopean stonework. There are no separate true courses, and the facing stones retain a rubble core. Dry stone construction was used throughout and the interstices between the neatly fitted large stones are finely chinked with small to medium sized stones. It is also evident that the lowest facing stones were partly propped up at the required sloping angle by a series of smaller stones. At some stage further layers of gritty red clay were used to hide such supporting stones from view before the whole external area was covered by a whitish clay surface. At the topmost level it can be assumed that the glacis face would have extended for at least one more meter where it would have met the vertical face of the now missing superstructure.

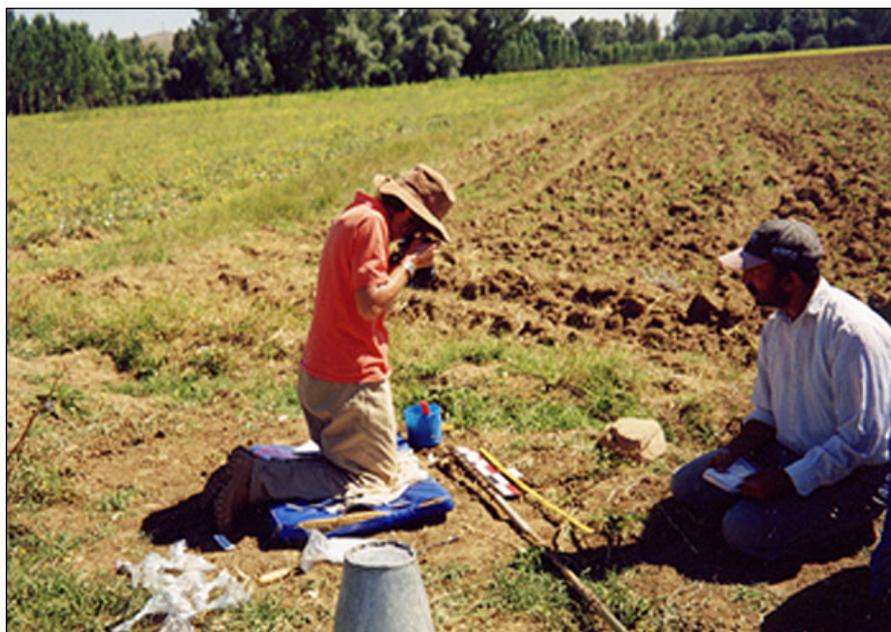
*Catherine Kuzucuoglu photographing the geomorphologic samples.*

A program of geomorphological research that aims at understanding the evolution of the Kanak Su basin in the Holocene period, with particular emphasis on the impact that the foundation of the Iron (**Fig 19**) Age city on the Kerkenes Dağ had on the surrounding landscape and environment, was begun in 1999. The goal of the 1999 research was to test the possibility of gaining useful results from a series of cores through the sediments in the Eğri Öz Su valley which lies immediately north of the Kerkenes Dağ and into which most of the rain water and snow-melt for Kerkenes drains. Three cores were made from samples of the sediments will be analysed during the coming months. Initial results suggest that, as predicted, there are several meters of recent sediment filling the valley and that a more extensive program of geomorphological and sedimentological research will be extremely worthwhile. This scheme of research, however, falls largely outside the realm of archaeology in both its geographic scope and in its chronological range. Thus some other mechanism for continuing this stimulating study in future years will be sought.
