## THE 2004 SEASON OF EXCAVATIONS

### **The Summer 2004 Activities**

### **The Monumental Entrance to the Palace Complex**

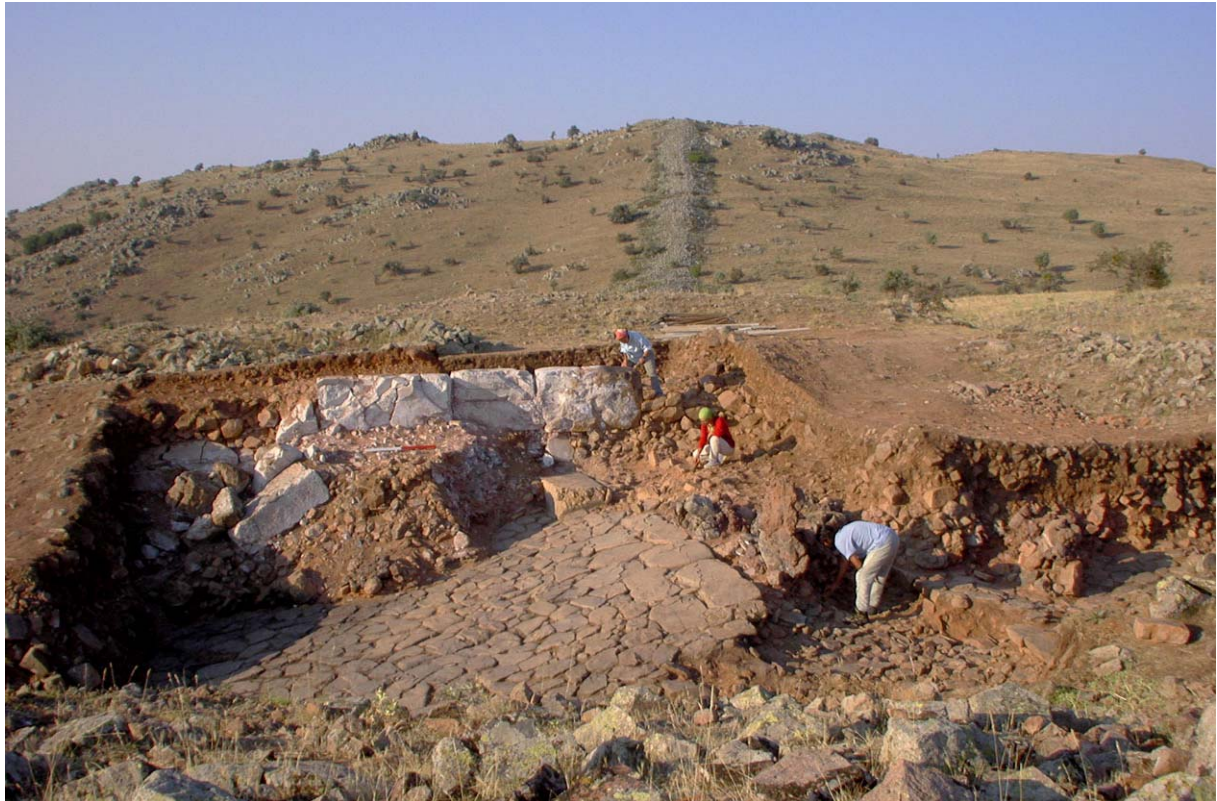
*Figure 14. The upper end of the pavement with the salt-encrusted north wall of the South Tower and the conglomerate plinth. The 1m scale rests on burnt debris at the base of which a layer of charred reeds can be seen in the shadow at left. Part of the city wall appears in the background. (04dpjv2505)*

The Monumental Entrance to the Palace Complex (Figs 13, 14 and 15) was partially excavated in 2002 (TR01), 2003 (TR11) and 2004 (TR14, TR15 and TR16). The inclined stone paved entranceway, flanked by two massive towers, appears to run in a westerly direction towards the palatial 'Audience Hall' that was partially excavated in previous seasons (trenches TT22 and TR02). A large conglomerate plinth to the left of the doorway was perhaps the base for a lion or sphinx. The construction of the entrance formed part of a remodelling of the Complex in a scheme that involved cutting through the southern side of the stone glacis and blocking of the paved way that led to Structure A. The complexities of the phasing are not yet fully elucidated.

1. Building of Structure A and its supporting glacis at the base of its northern, eastern and southern sides (shown on the key plan of Fig. 13). The paved way, edged with large stones on its north-eastern side, leading to Structure A (the south-eastern edge of which can be made out in Fig. 14 at top).
2. North-eastern extension to the paving, of inferior workmanship (at the far end of the excavation in Fig. 15 at top).
3. The construction of terraces, Structure B, built on top of the pavement and cut through Structure A (Fig 13).
4. Construction of the Monumental Entrance (Figs 13 and 14).

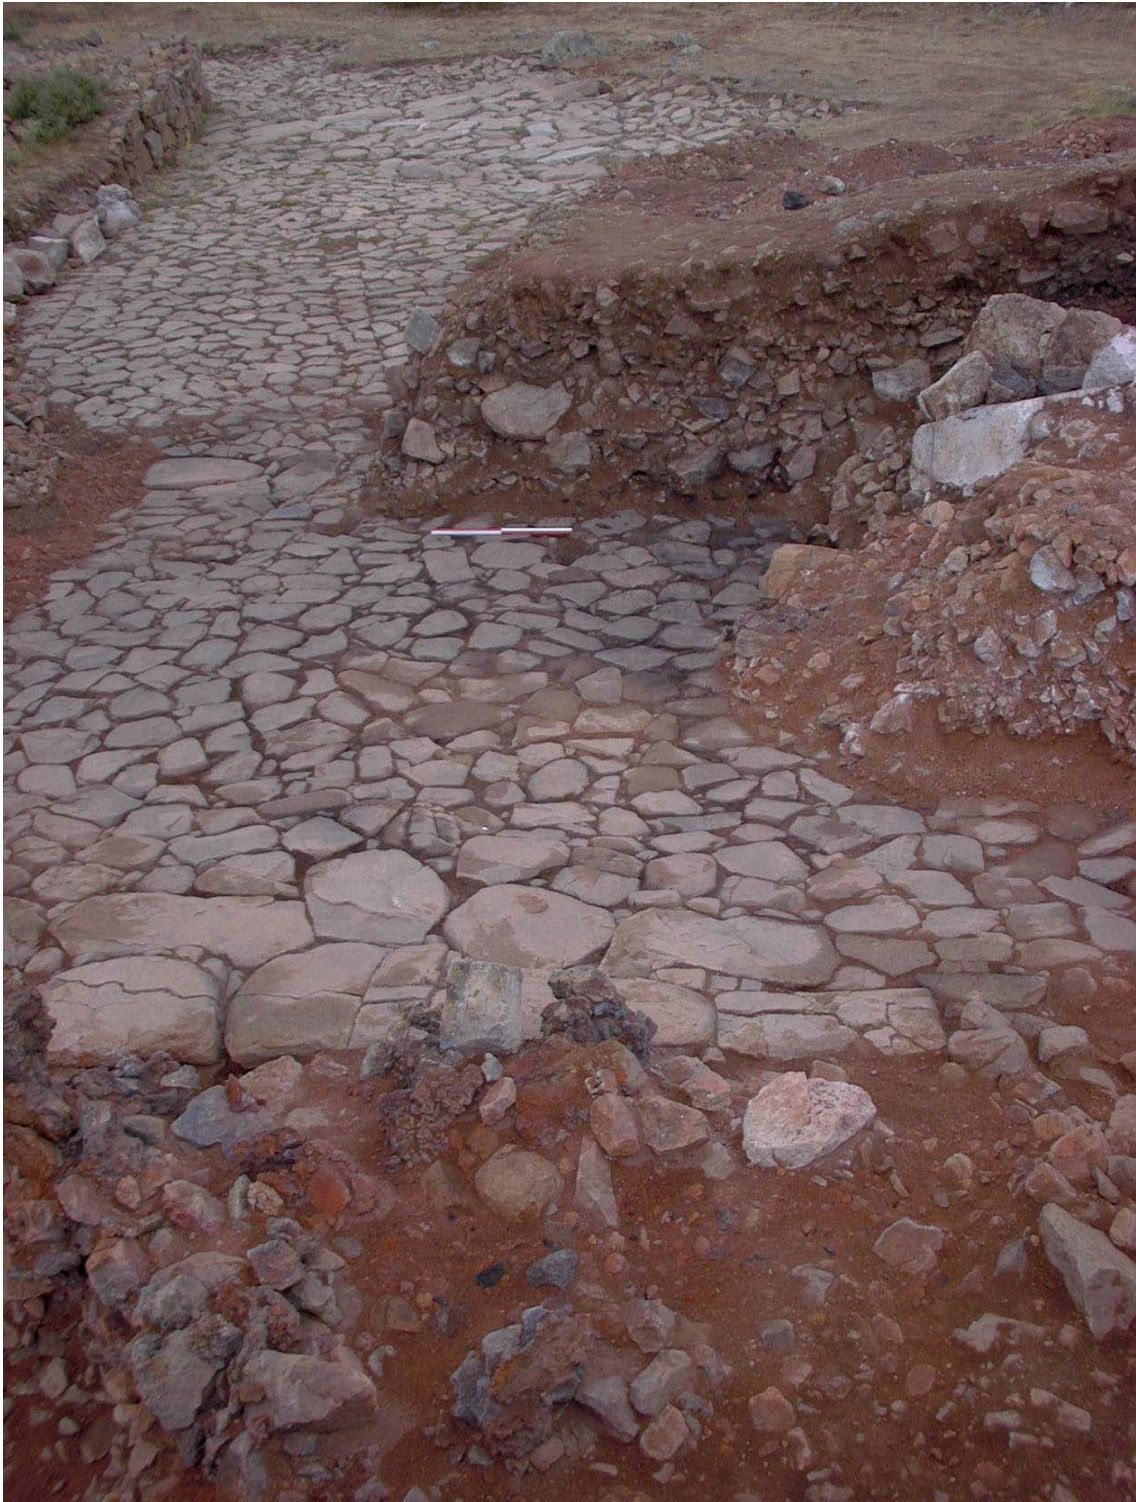
*Figure 15. The inclined pavement looking east. Burnt and fused debris in the foreground indicates the position of a monumental wooden screen and large double leaved doors. The section behind the scale is entirely fill of the robber pit from which the statue fragments were recovered. (04dpjv2307)*

The stone paved area leading to the Palace Complex Entrance ended against a wide wooden partition which had burnt totally away leaving a void into which the burnt and fused superstructure of the towers collapsed. The position of the large pavers indicates the width of the double leaved doors and in the centre, where the trench is most restricted, they mark the front of the Monumental Entrance, beyond which setting lines in the earlier paving are on a different orientation (Fig. 15).

The stratigraphic, and therefore chronological, relationship between phases 3 and 4 of this scheme, i.e. between the Monumental Entrance and Structure B, is not (yet) known. Further, the precise number of phases in the laying of the stone pavement, as opposed to lines that merely represent working methods, is unclear. However, the alignment of setting lines within the paving (two of which are visible in the middle ground of Fig. 15) makes it highly

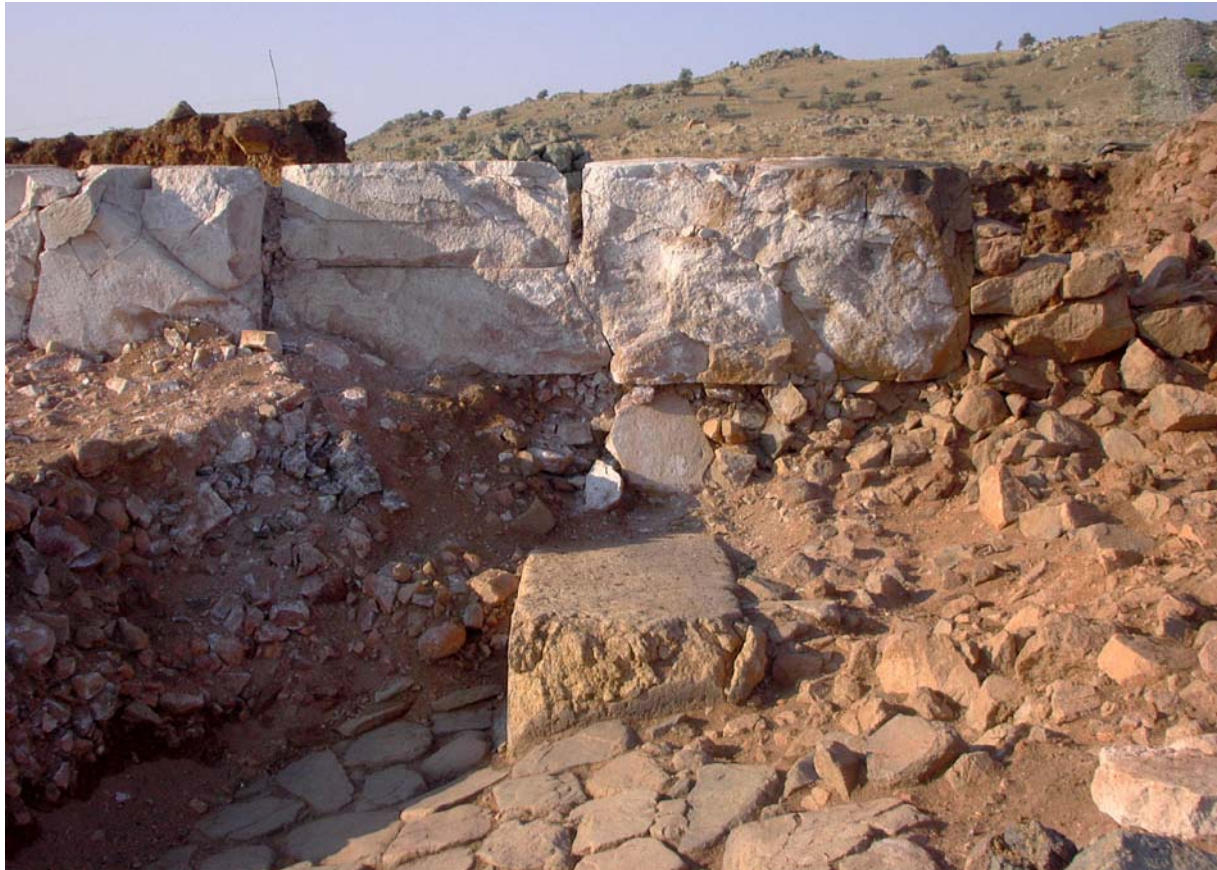
*Figure 16. The north wall of the South Tower is structurally unstable due to the burning of horizontal timbers between the courses of large blocks. A large conglomerate plinth set into the granite pavement and trimmed in situ, may have been the base for a lion or sphinx. (04dpjv2512)*

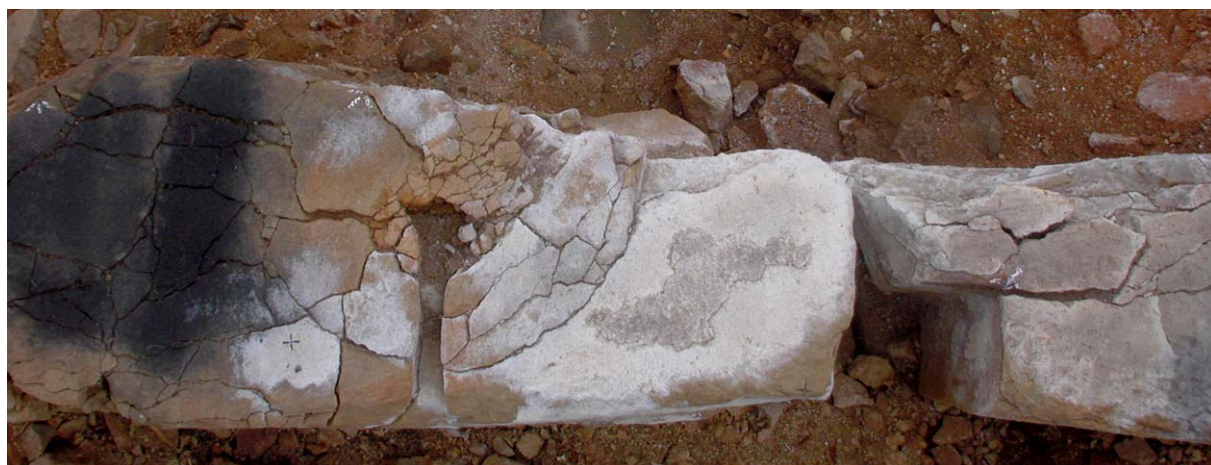
*Figure 17. A square cutting was carved out of one of the sandstone blocks of the South Tower wall presumably to locate either a vertical timber or a floor beam. To the left, a clamp cutting perhaps held a wooden clamp that tied the block to floor joists. The soft sandstone has been shattered by the fire and is encrusted with salts. (04dpjv2848)*

In the north wall of the South Tower a square indent was carved out of one of the sandstone blocks presumably to take a vertical timber although it could perhaps have taken a floor beam (Fig. 17). The inner, hidden face of that same block has a mason's mark. The burning of the interlaced large timbers greatly damaged the stonework to the extent that little can be saved.

The wooden 'swallowtail' clamps used at Kerkenes display surprising variation in size and considerable irregularity, no use being made of templates (Figs 17, 18 and 19). The clamp cuttings appear to have been cut into the soft sandstone and conglomerate with simple woodworking tools, even though the row of cuttings for small mending clamps in a single granite block would have required more effort and different techniques. This use of wooden clamps reinforces the idea that the methods used for cutting the sandstone were essentially derived from carpentry. There is only one granite block with cuts for clamps, these clearly for mending a crack (Fig. 18). It would seem that on sometimes adjacent sandstone blocks were locked in place by wooden clamps which tied them together.

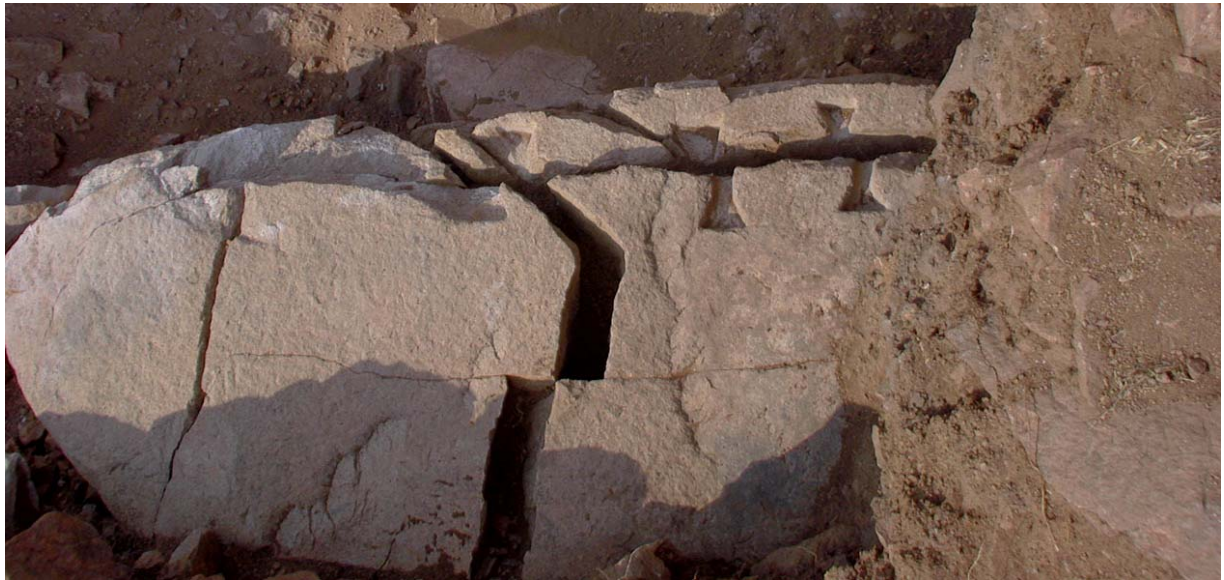
*Figure 18. A row of small clamp cuttings for mending the front of a split granite block in the north wall of the South Tower. This is probably a corner stone, the end being just beyond the baulk at right. (04dpjv2219)*

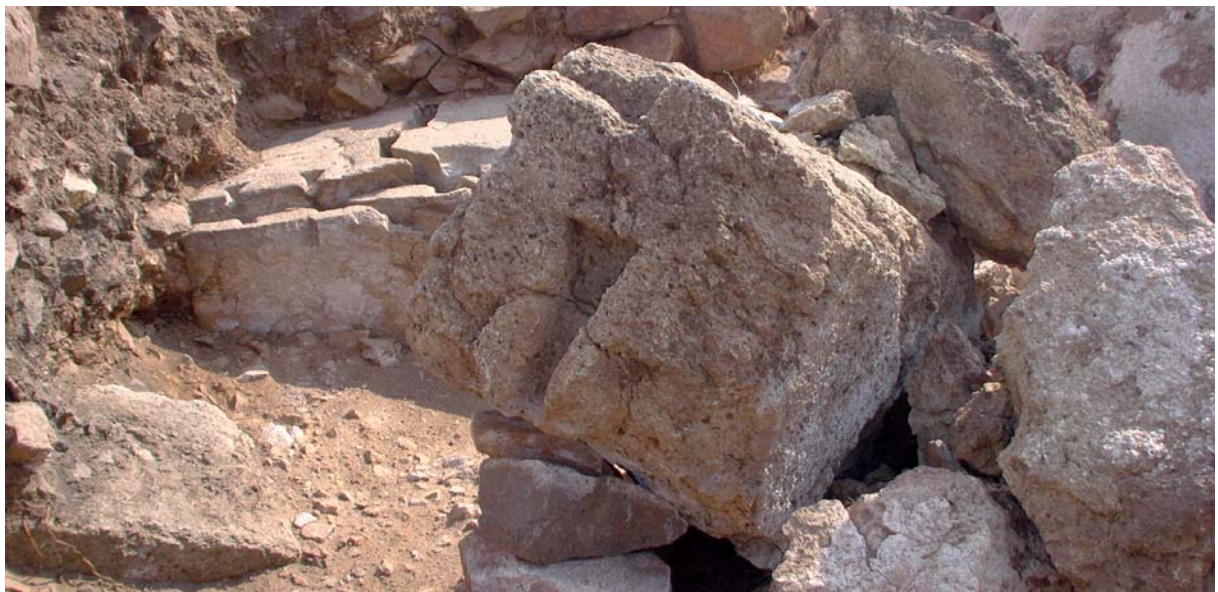
*Figure 19. A fallen block of conglomerate has two clamp cuttings, that on the top left being incomplete. The granite block seen in Fig. 10 is in situ in the tower wall behind. (04dpjv2215)*

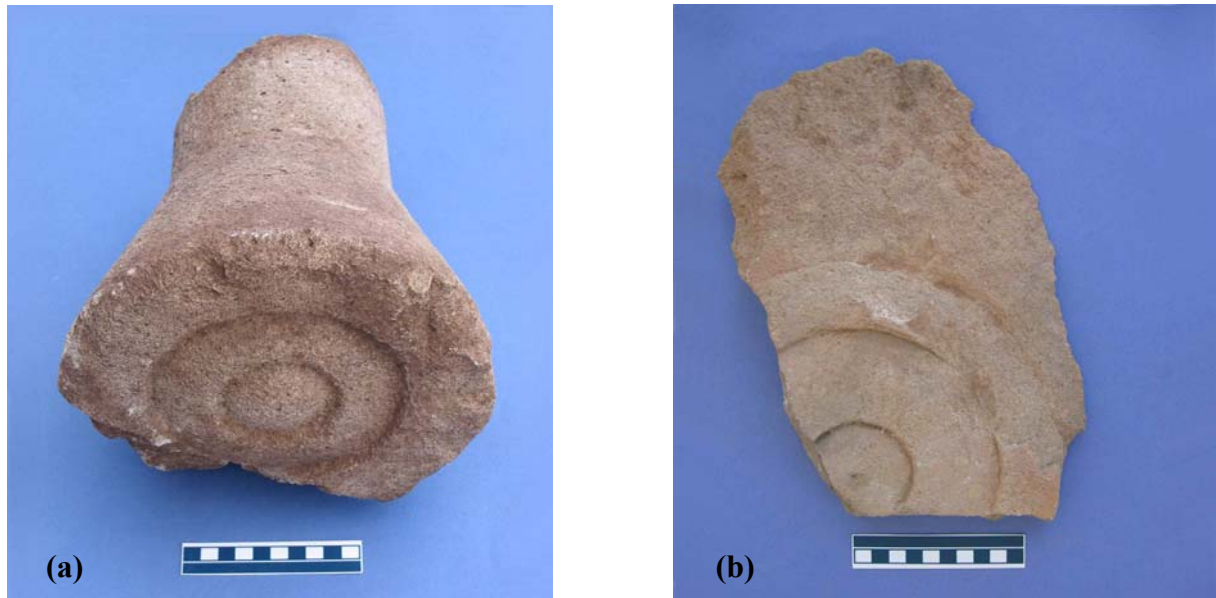
*Figure 20. (a) Part of a large three-quarter round bolster with bevelled edge. The scale is 10cm. (04dpcs0421)  
(b) Part of a large bolster end carved in relief. The scale is 10cm. (04dpcs0107)*

were once part of an ornate sandstone capital for this large wooden column, probably of similar general form to the smaller example (Figs 20 and 21). There is no evidence as to the pitch of the roof, or the height of the pediment apex above the pavement, but it is not unreasonable to suggest that the height would have been approximately the same as the width, i.e. 10m. The use of reed thatch, the burnt remains of which lay on the paving, would suggest a steep pitch to facilitate the runoff of rainwater and snow. The slope of the entrance passage would have necessitated a comparable slope in the roof ridge.

The term bolster has been adopted from the terminology long employed to describe similar elements, all be it on a much smaller scale, found on handles of bronze bowls and pottery from the Iron Age of Central Anatolia. In shape, the bolsters comprise conical elements at either end of a central cylinder. The end faces are decorated with compass-drawn concentric circles (Fig. 20a and 20b). Several pieces of bolsters were found in 2003 and 2004, a particularly well preserved examples (Fig. 20a) being added to the assemblage this year.

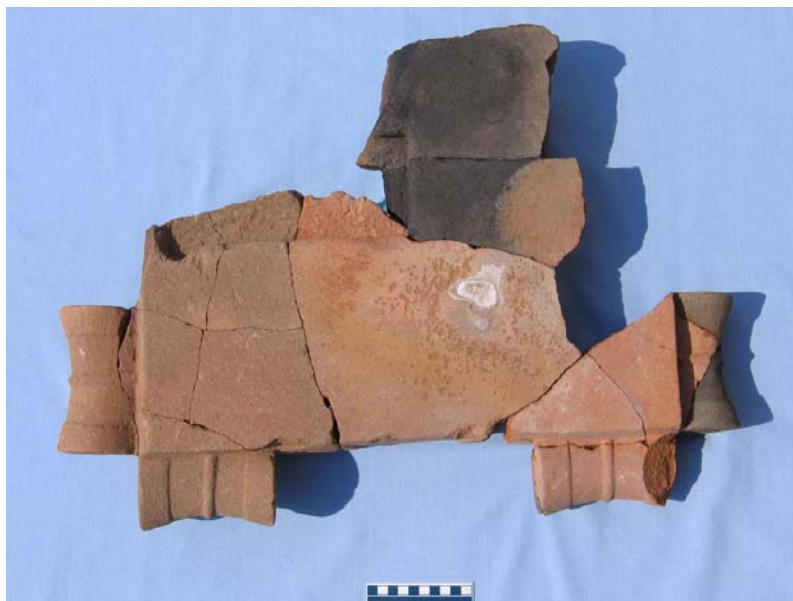
*Figure 21. Part of an architectural block, with an offset recess and, on the underside, a square dowel cutting. Three-quarter round bolsters at each corner with pairs of bolster ends between. The scale is 10cm. (04dpcs1005)*

Smaller examples of bolsters belonging to a square sandstone block (Fig. 21) have a raised ridge or bead moulding around the centre of the cylinder. This architectural piece was embellished with three-quarter bolsters at every corner with concentric circles representing bolster ends between them. Additional fragments (not illustrated) were recovered in 2004.

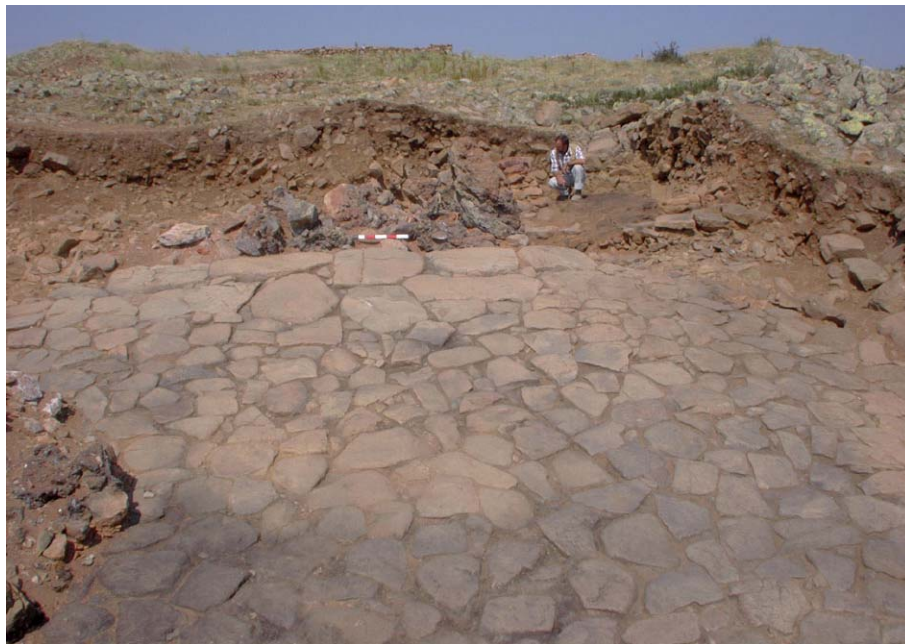
*Figure 22. The pavement running to the doorway of the Monumental Entrance marked by the large edge-stones. Burnt debris and ash on the pavement contain evidence for a pitched roof of thatch above the passage. (04dpjv2355)*

Whatever the eventual resolution to the complexities of phasing may be, the overall architectural scheme of the Monumental Entrance (Fig. 22) is now emerging. Figure 13 provides a tentative reconstruction of the towered and paved entrance together with an inset key plan that shows the location of the trenches as well as the position of the Entrance in relation to both Structure A and the terraces of Structure B.
