THE KERKENES PROJECT

A PRELIMINARY REPORT ON THE 2005 SEASON

Geoffrey and Françoise Summers

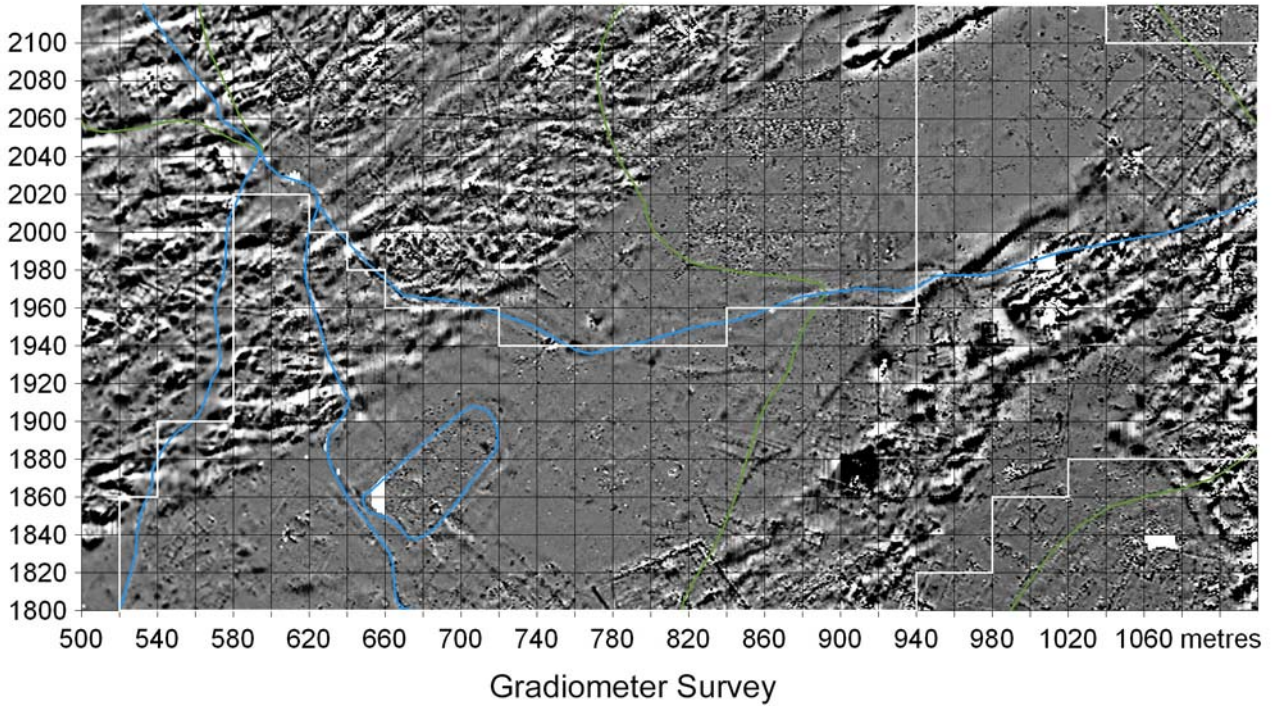
Figure 12. Samples of geophysical maps of the Central Area, including the Büyük Göl or Large Reservoir, show that survey with a Geoscan FM36 fluxgate gradiometer (above) does not reveal structures in as much detail as with a Geoscan RM15 resistivity meter (below). Resistivity survey is slower, however, allowing an average of nine grids a day compared to 30 grids for the gradiometer survey.

Test excavations confirmed that visible differences in results between both methods of geophysical survey are indications of different buried surfaces, notably burnt clay floors of roofed structures and external stone pavements. Further, comparison of the two sets of data make apparent some of the ways in which burning has had an effect on the magnetism.

Advantage was taken of very damp conditions at the start of May to investigate one particularly large urban block on the rising eastern margins of the Central Area, located by its southern corner at E1088, N2015 (Figs 11, 12 and 15). The boundaries could be seen on the surface and it was evident that it was bounded by a broad street on the NE side and, most probably, by streets at either end. At the outset it was not certain if the level walled area adjacent to the NW edge of the block was an extension of the block itself or a street. The main objective was to establish whether or not this block contained a large two-roomed hall. The excellent results (Fig. 15) showed that at Kerkenes considerable potential for resistivity survey exists, even over stony areas, when there is sufficient ground moisture.

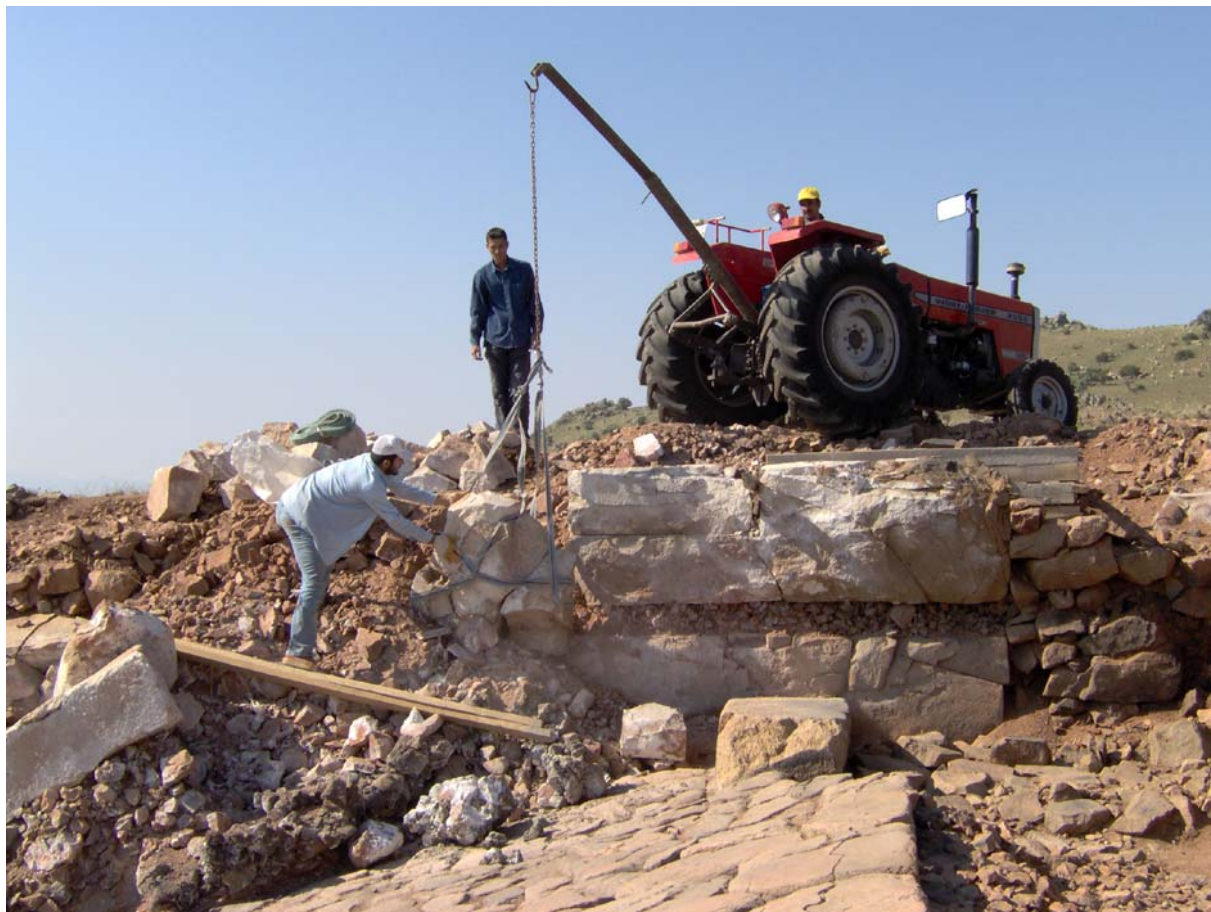
Figure 24. The horizontal gap left between courses after the horizontal beam completely burnt down caused the wall of the South Tower to become structurally unstable. Facing blocks and burnt debris are naturally coated with white carbonates. Many of the large stones, shattered by the intensity of the fire, had to be removed for safety. (05dphp1104)

While it may be said with confidence that nothing of importance was missed, it is sad to report that the intensity of the fire had so broken the masonry of the passage walls that very little remains *in situ*. The horizontal gap left between courses after the horizontal beam completely burnt down caused the wall of the Towers to become structurally unstable. Many of the large stones shattered as the result of the intensity of the fire had to be removed for safety. As a temporary measure wood was used to prop up what remains of wall facing, but this has been done for safety pending implementation of a conservation and restoration program.

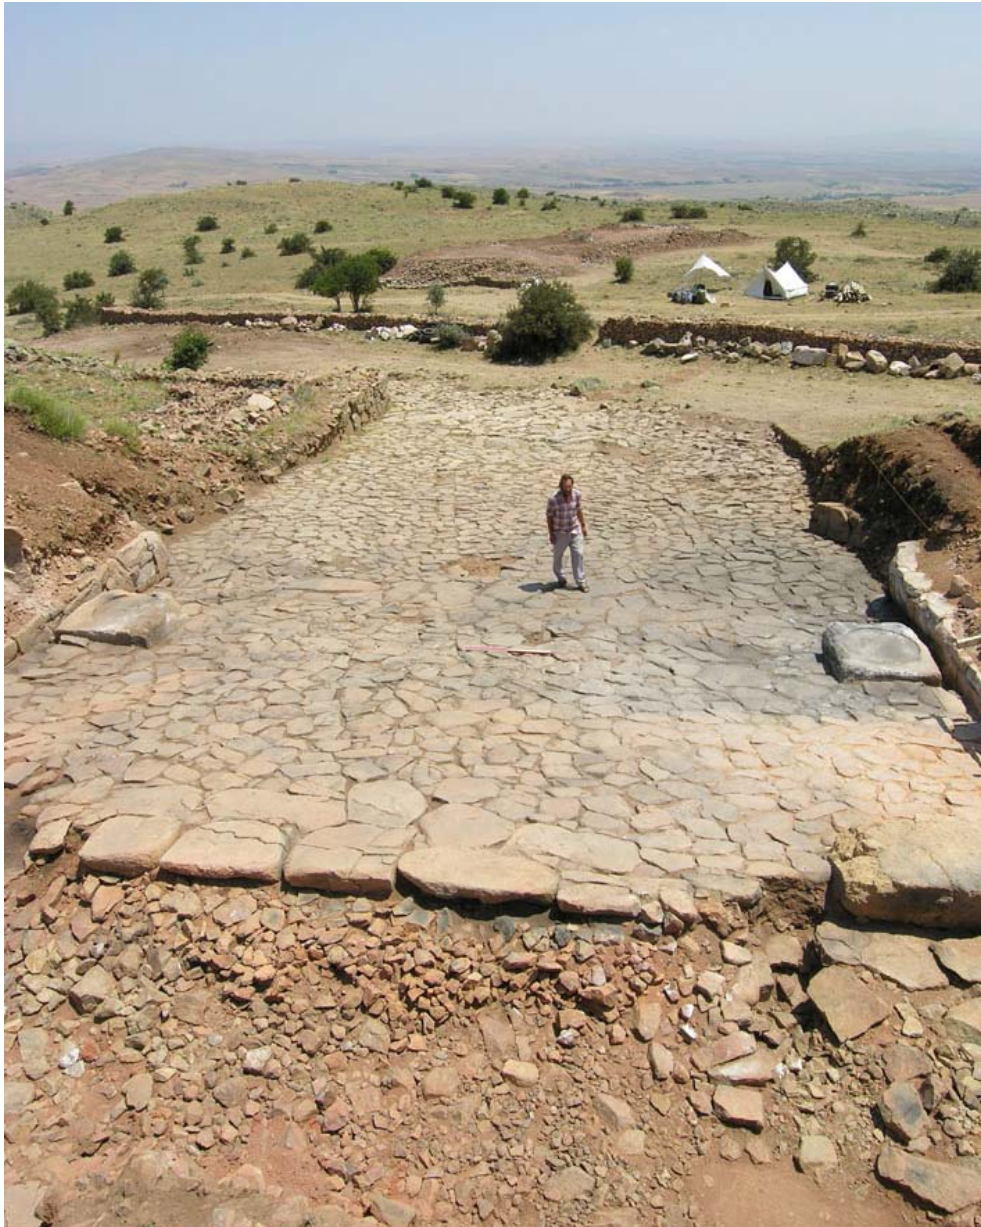
Figure 28. The Monumental Entrance looking east with, in the foreground, the foundation trench for the front façade. Five large pavers demarcate the doorway, with robbed sockets on either side. At bottom right, the surviving conglomerate plinth. The front corners of the massive towers, 10.50m apart, project beyond the column bases. (05dpnc0957)

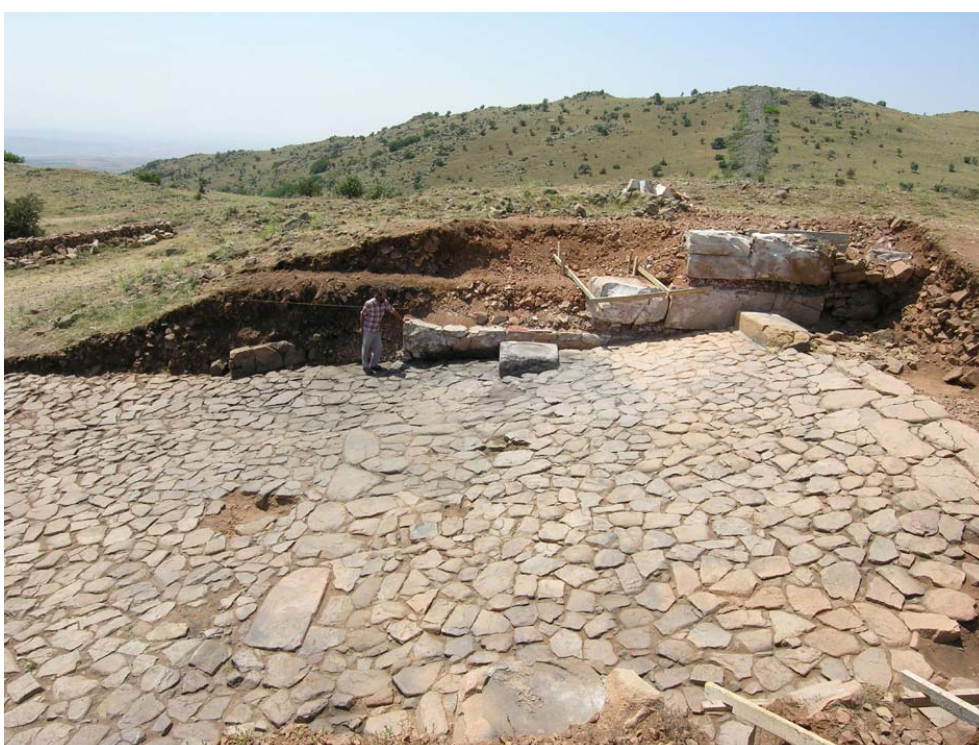
Figure 30. The stretch of stone pavement between the front half of the two towers is 10.50m wide and the two column bases stand 9.20m apart from centre to centre. Beams between the courses of huge cut blocks burnt out completely, causing the wall to fracture and collapse. (05dpnc0862)

The front half of the broad passage, which is inclined at a gradient of approximately 1 in 5, is paved with granite worn to a polish (Fig. 30). Setting lines in the portion of pavement in front of the towers are not parallel to the orientation of the entrance but lead to the doorway of the Audience Hall (Figs 20 and 27), demonstrating that the original pavement and the Audience Hall pre-date the construction of the Monumental Entrance. At the inner front corner of each tower the top of a foundation stone can be seen slightly above the level of the top of the pavement and projecting in both directions for a few centimetres beyond the line of the upper walling. This slightly wider footing appears, however, to be restricted to the corner stones and is not observed along the tower walls rising up the passage slope (Fig. 31). The square sandstone column bases on either side, set back c.2.05m from the front of the towers, have shallow circular recesses c.0.85m in diameter. In all probability these were for tall, freestanding wooden columns provided with sandstone capitals (although an alternative possibility is discussed below). These bases were shaped in position, as was the rectangular conglomerate plinth preserved at the southwest corner of this front portion of the entrance. The plinth, measures 2.10m by 0.70m and was presumably mirrored by another one on the opposite side of the door. From the front of the towers inwards the paving was re-laid up to the walling, column bases and the, presumably two, plinths. This may be demonstrated by the row of particularly large stones along the line of the tower fronts.

It is now thought that this front section of the Monumental Entrance was unroofed for several reasons. Firstly the span, while not impossible, seems very wide, particularly as there was only a single pair of columns. Secondly, the steep slope of the pavement would have made roof construction difficult. Thirdly, if it is correct to reconstruct a large timber façade founded in the wide slot at the top of the slope any roof would have obscured it from view. Lastly, it would seem that the distribution of burnt debris, in as far as it could be ascertained between the robbing pits, is perhaps more consistent with burning of the façade and double doors than that of a passage roof. The fragments of burnt roofing, including pieces of clay with reed and wood impressions as well as deposits of charred reeds most probably fell into the entrance passage from the towers on either side.

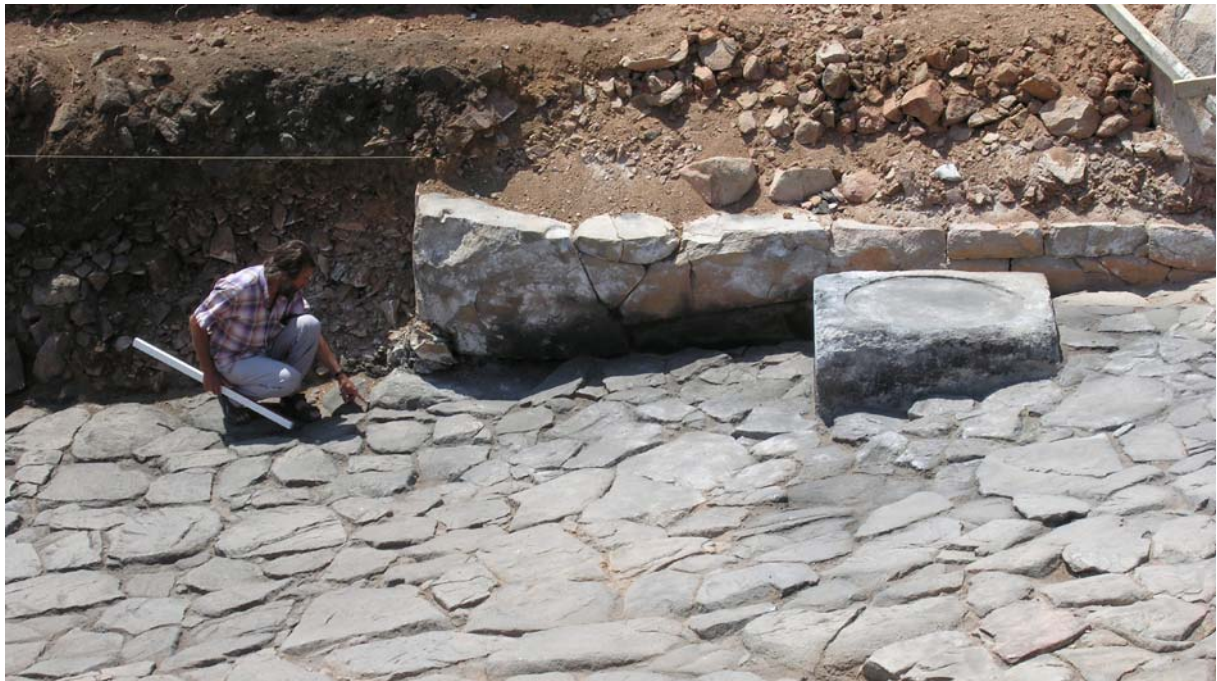
Figure 31. The northeast corner of the South Tower with Geoffrey Summers pointing at the projecting corner stone of the wall footings. The sandstone column base has a circular recess of c. 0.85m in diameter. (05dpnc0869)

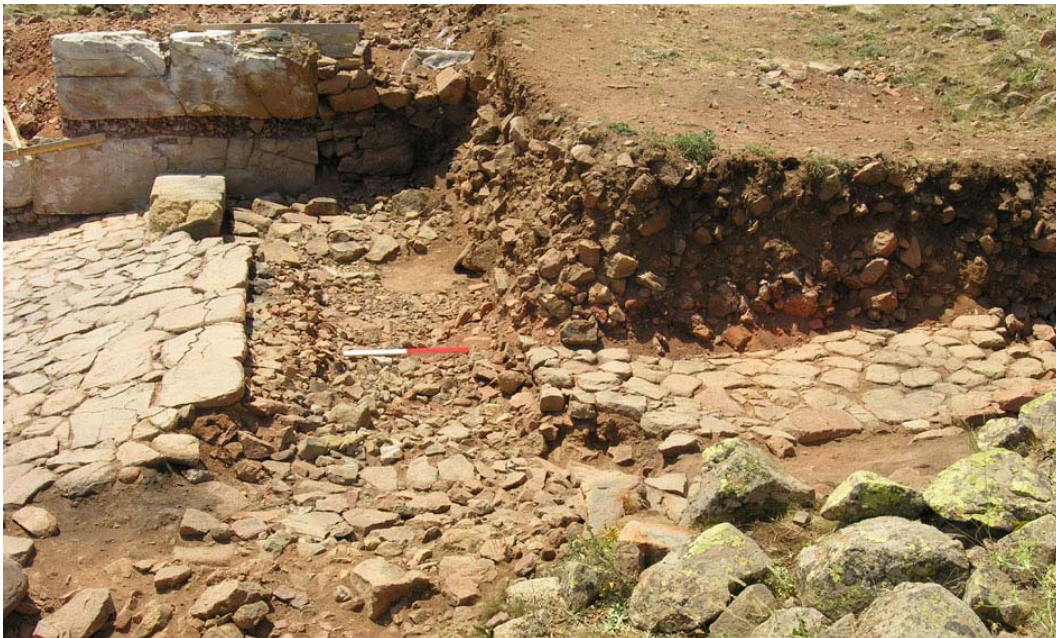
Figure 32. The foundation slot for the front façade with the large pavers indicating the position of the double door. The large blocks of the tower wall give way to small uncut masonry where it was hidden by the partition. The 1m scale lies on rubble left after the burnt and vitrified debris were removed. (05dpnc0910)

Approximately half way along the side of the towers, a 2.20m wide slot appears to be a foundation trench to a structure which has been described as the front façade (Fig.32). The burnt and vitrified debris and perhaps some traces of vertical posts indicate a timber frame structure with infill rubble and mudbrick.

An absence of ash and charcoal in the wide foundation slot, which was filled with masses of fused stone rubble and mud that most probably came from the upper walling of the towers as well as the core of the façade itself, suggest that the doors and possibly much of the partition itself may have been pulled down before the fire. Additional evidence that the doors were pulled out prior to the burning came in the form of fragments from a small sandstone bolster recovered from the hole for the southern doorpost.

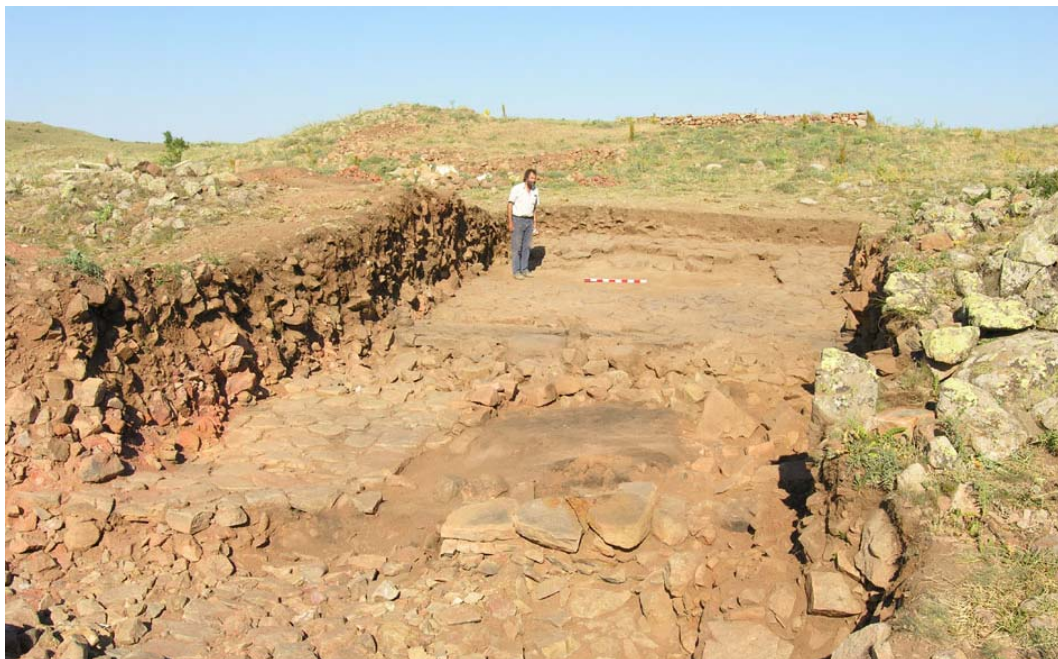
Figure 33. The excavated half of the inner portion of the entrance, between the front and rear façade. A burnt clay floor indicated the location of a small room in front of which was a bin like feature. The 1m scale is on the western stretch of pavement leading to the Audience Hall that can be seen in the background. (05dpnc0209)

Passing through the double doors of the front façade led to a second paved and levelled area where the paving stones are smaller and exhibit less signs of wear (Fig. 33). A burnt clay floor indicated the location of a small room in front of which was a bin like feature. As suggested on the plan (Fig. 27), it is reasonable to assume that there was a symmetrical arrangement and a room on the unexcavated southern side mirrored that on the north. No alterations were made to either this portion or to the rear section of the entrance before the destruction.

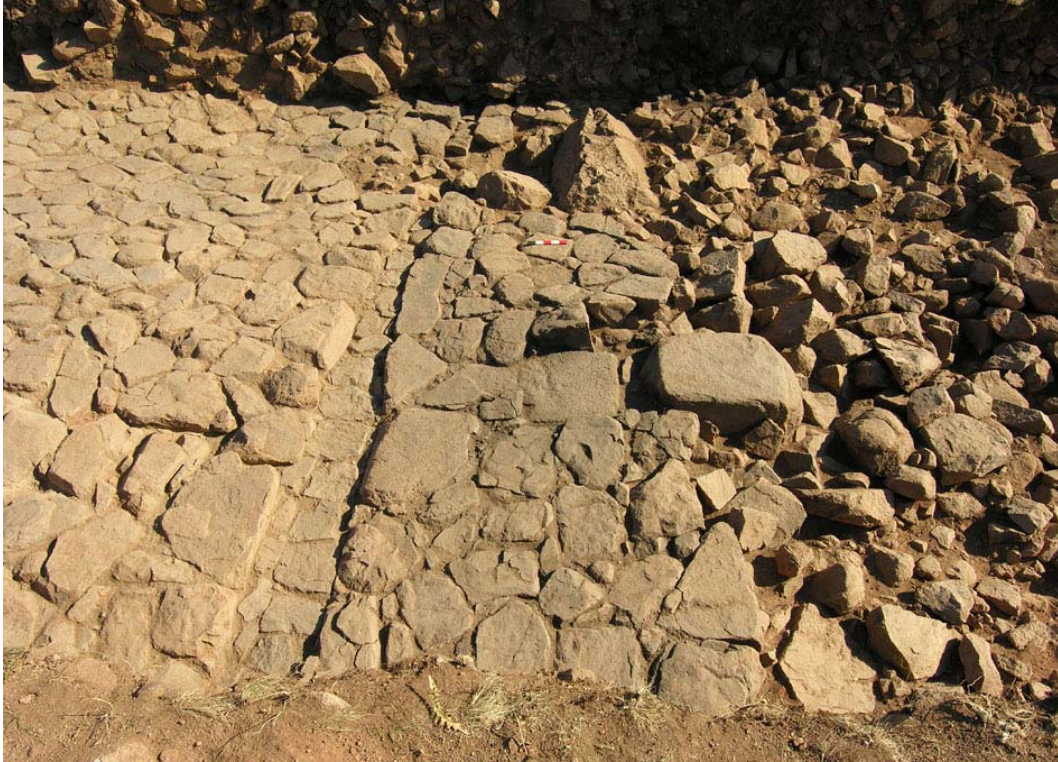
Figure 38. A drain set into the pavement along the rear façade took surface runoff away from the entrance in a northerly direction. (05dpnc0218)

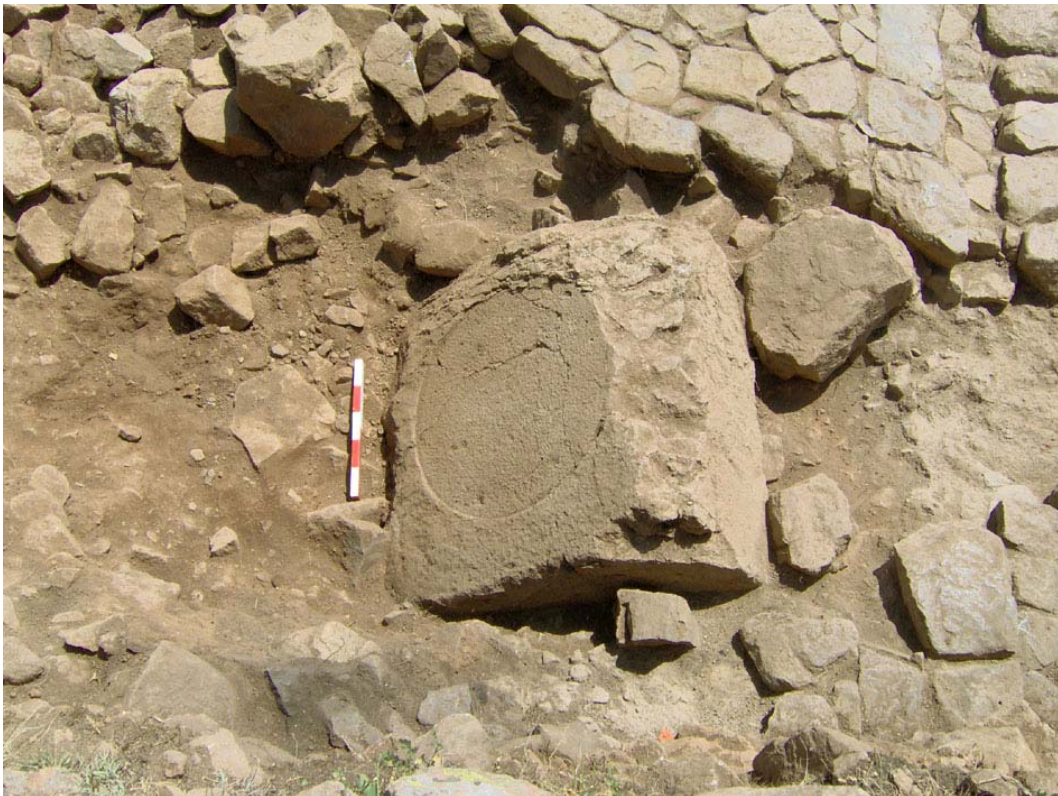
Figure 39. A square column base with a circular recess for a wooden column was found tilted into a robber pit. (05dphp2116)

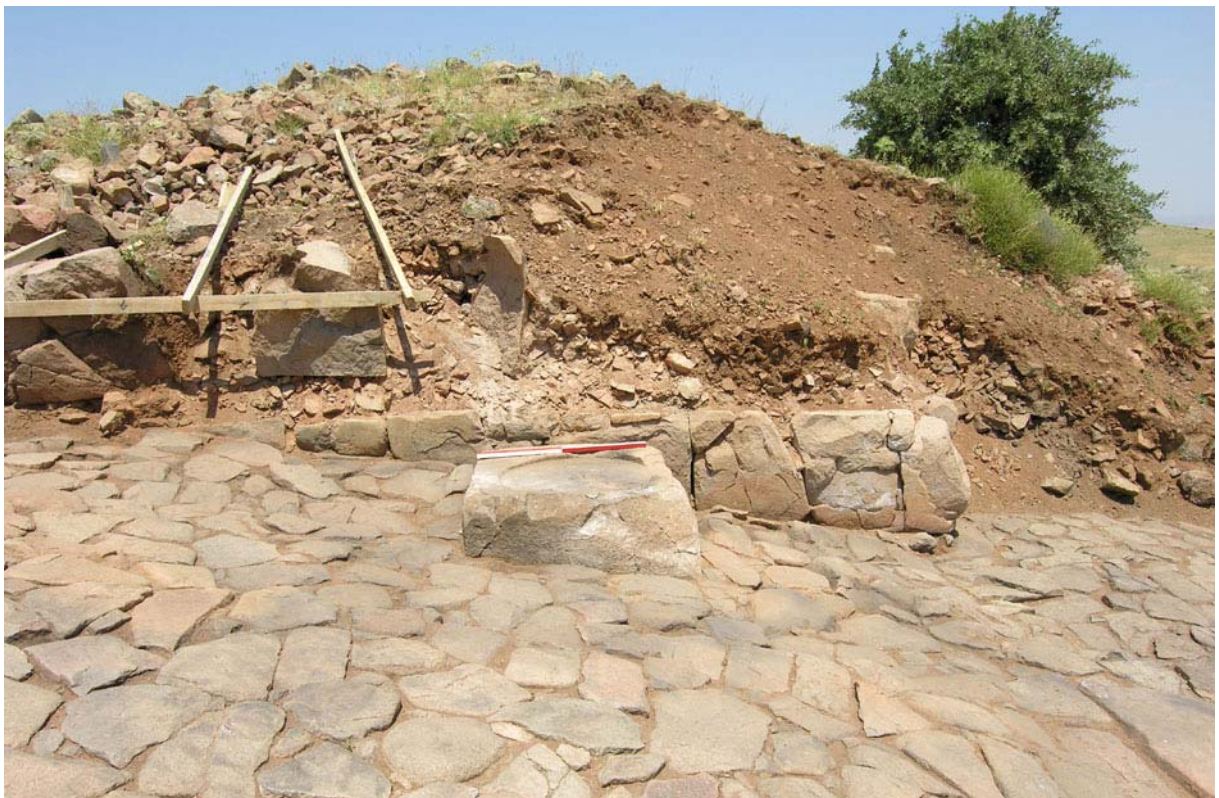
Figure 41. Only the lower course of the walls of the North Tower was stable enough to remain in situ. The scale on the column base is 1m long. (05dpnc0967)

In plan, the towers are rectangular and each measure approximately 15.60m by 13.00m. The position of the rear face has not been exactly ascertained, precluding precise determination of their length. The corner of the South Tower was exposed after the collapse (Fig. 40) was carefully recorded and removed. Little was done by the North Tower apart from cutting back further the dangerously loose edge of the excavated area (Fig. 41).

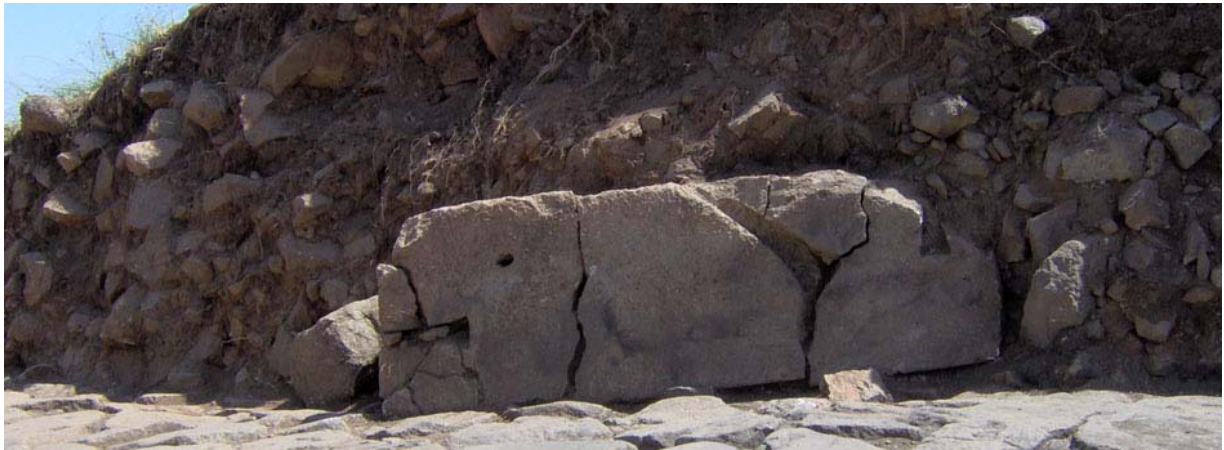
Figure 43. Clamp cuttings on a block fallen from the South Tower. (05dphp2111)

An important detail, not least for the chronology, is the use of wooden swallow-tail clamps, the charred remains of one having been recovered in the cutting itself. Small neatly carved clamp cuttings were recorded on the two large, faced, granite blocks, that stood on the northeastern corner of the South Tower and the adjacent block to the west. These smoothed clamp cuttings were for mending granite blocks that had broken during construction. In the sandstone, by contrast, there were numerous swallow-tailed clamp cuttings. There were deeper, not particularly regular and rather rough clamp cuttings, exhibiting considerable variation in size, in the sandstone (but not apparently in the soft limestone). They appear to have been cut with the same tools as were used for shaping and finishing the sandstone and limestone blocks (but not the much harder granite), and essentially these appear to be woodworking adzes and chisels. Clamps were used to join adjacent blocks in wall faces and, at 45° angles, to brace blocks on tower corners (Fig. 43). In addition there were, as reported last year, clamp cuttings that perhaps secured facing blocks to floor joists. It can be argued that the beams were floor joists rather than timber lacing within the core of the tower since in the latter case some evidence of charred timbers would have been recovered.

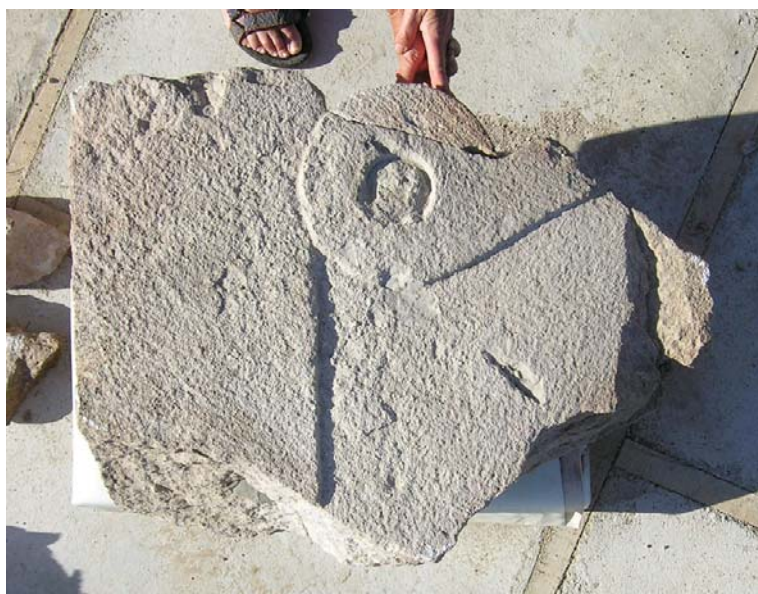
Figure 47. Large carved block with raised margin, roundel and diagonal band which might indicate the angle of roof pitch. (05dpnc0176)

A number of large carved sandstone elements were recovered amongst the collapse that most probably fell from the northeast corner of the South Tower. It can now be understood that the southeast corner of the North Tower must have been provided with matching elements of which few fragments survived. While it is clear that the general scheme included bolsters and bolster like elements, more work is needed to reassemble broken fragments before a convincing reconstruction of the architectural scheme can be finalised. Some of these blocks bear “masons marks” that resemble (single) Old Phrygian letters. A large block (ID 05TR17U12arc11) has a raised edge band and a circular feature at the end of a diagonal band (Fig. 47) which is thought to indicate the angle at which a roof or pediment was pitched.

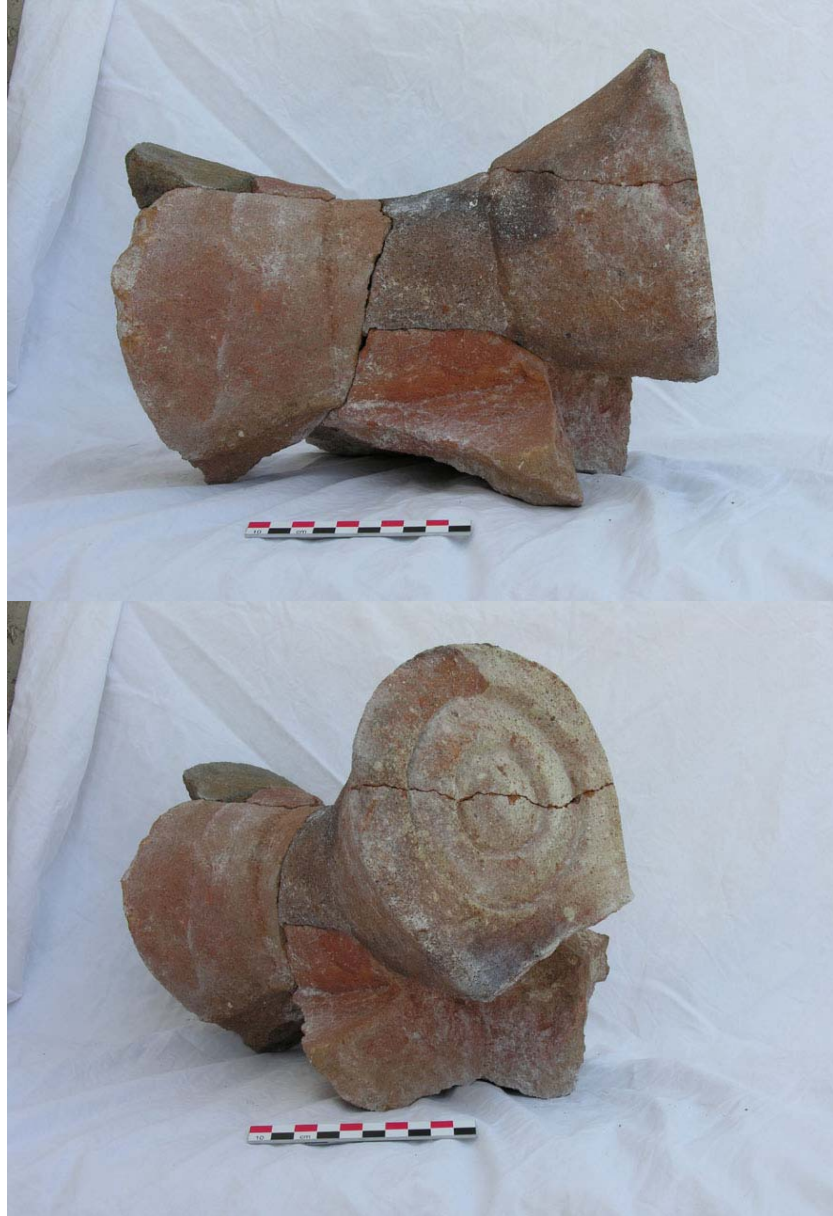
Figure 49. Side view (above) and end view (below) of a medium-sized sandstone architectural bolster, ID 05TR16U14arc04, recovered from the collapse of the South Tower. The scale is 10cm. (05dpnc2019-20)

Sandstone bolsters (e.g. Fig. 49 for bolster ID 05TR16U14arc04), in addition to those mentioned above, were found in a variety of sizes. It would seem that some of these and very possibly all except the small examples that belong to a square element from a freestanding monument illustrated in previous reports, appear to have come from the walls of the towers.

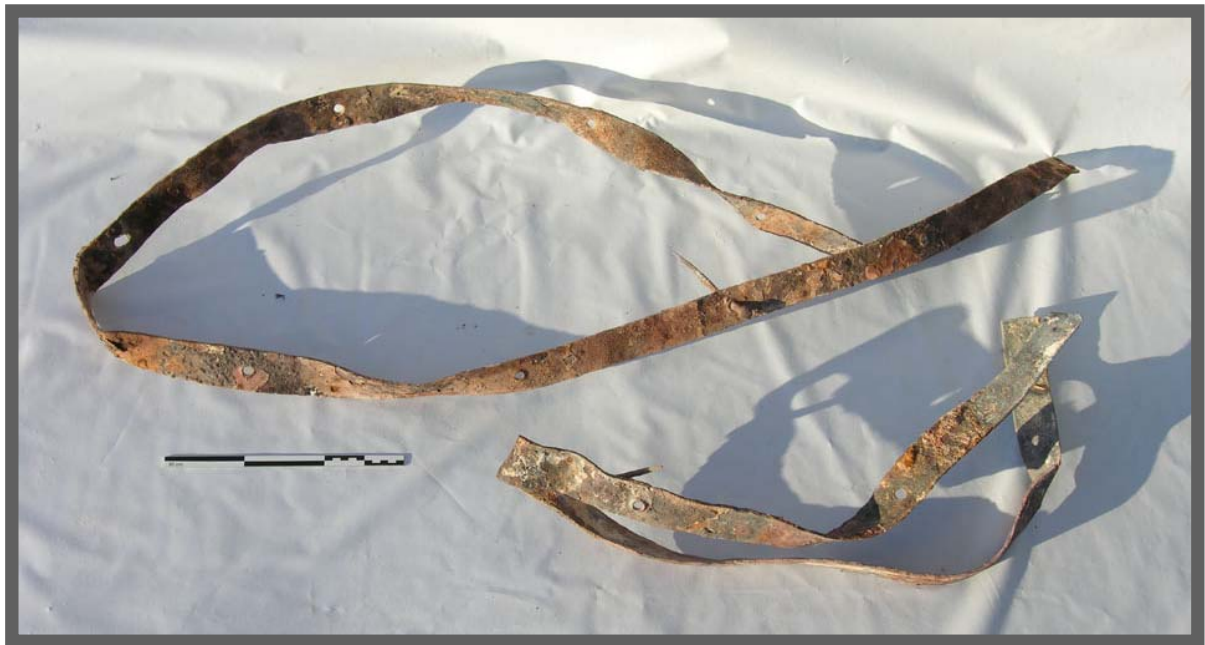
Figure 55. Two iron bands, K05.191 with ID 05TR16U18met05, K05.192 with ID 05TR16U18met06, pierced with some nails still in place, probably from wooden doors. The scale is 30cm. (05dpnc1369)

Two large iron bands (K05.191 with ID 05TR16U18met05, K05.192 with ID 05TR16U18met06), almost identical to those discovered in 2002, were found against the tower wall on the south side of the passage. Fragments of similar bands were also recovered from the inner end of the entrance, although these were less well preserved than the complete bands from the front which are still tensile to this day. Some of the holes punched through these bands still contained large dome-headed nails (Figs 55 and 56) while fugitive nails were found in the burnt debris nearby. It is thought that these derived from the doors, their being two horizontal bands on each. The dimensions are not inconsistent with this interpretation and the find spots lend further support the conclusion that the doors had been taken down before the fire, perhaps to remove metal embellishment and to loot out metal door sockets.

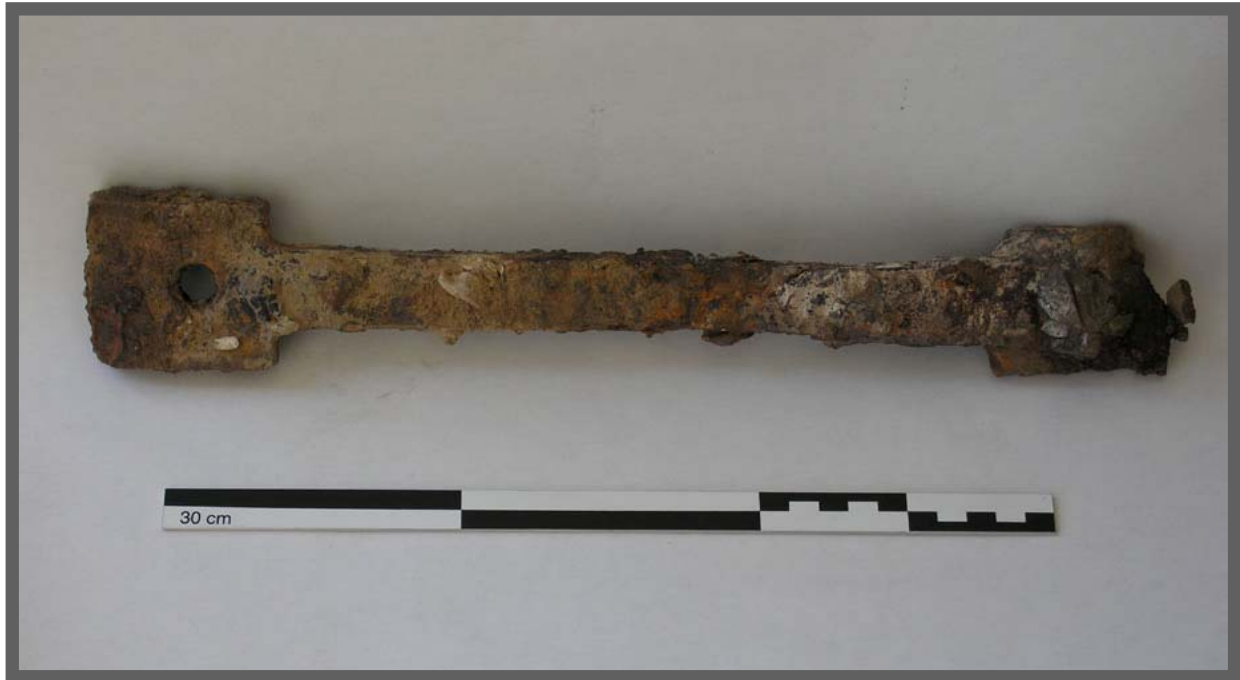
Figure 57. Iron brace, K05.207 with ID 05TR17U14met07. (05dpnc1541)

A second large iron brace (K05.207 with ID 05TR17U14met07) found in 2005 near the South Tower is very similar to the one found in 2002 by the North Tower and amplifies the architectural symmetry of the entrance. The brace (Fig. 57) has squared ends and large dome-headed nails.

In addition, a number of smaller braces with splayed ends and smaller nails paralleled those found in the two previous seasons. Like the bands described above, these iron braces are witness to the structural importance of iron in strengthening timber construction.
