# **THE KERKENES PROJECT**

## **A PRELIMINARY REPORT ON THE 2005 SEASON**

**Geoffrey and Françoise Summers**

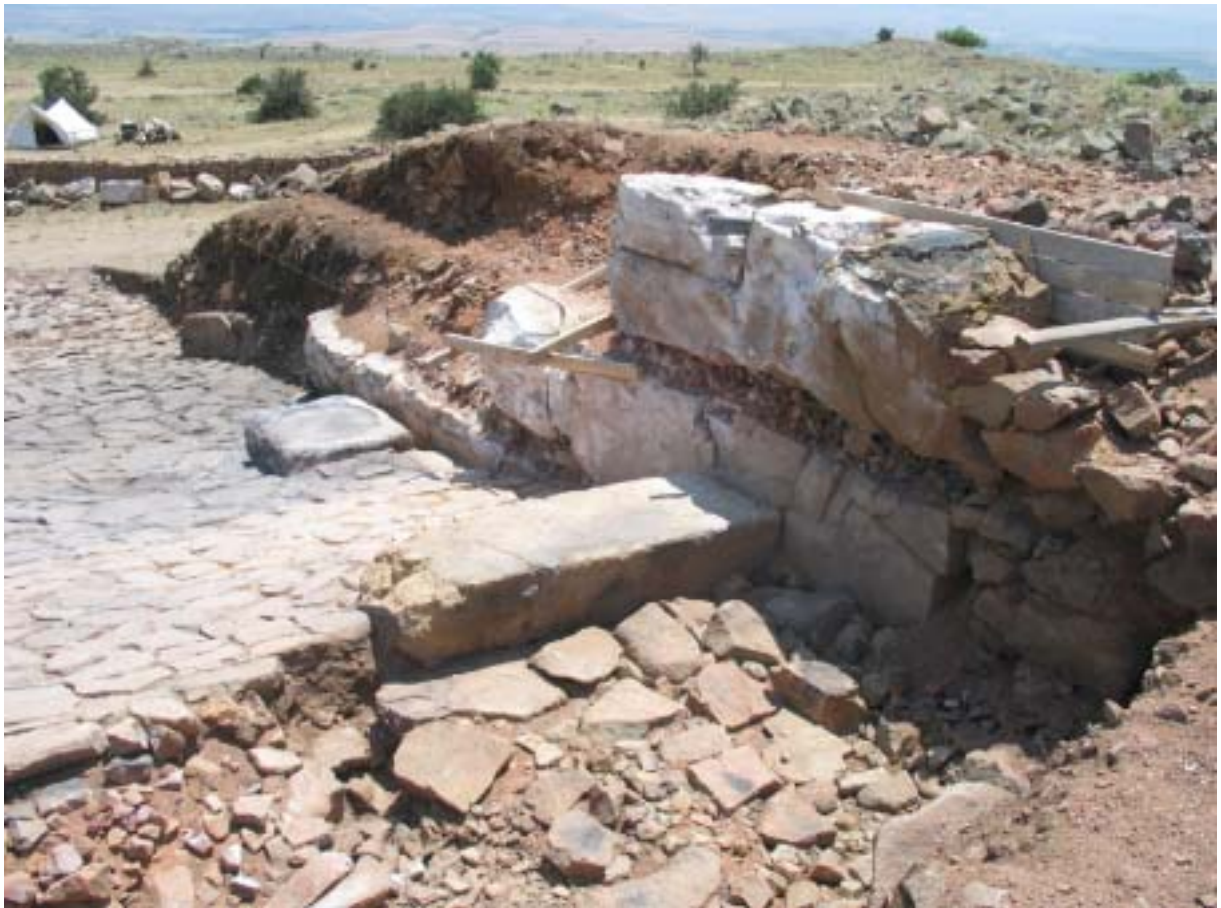
*Figure 1. Excavation at the Monumental Entrance  
to the Palace Complex. (05dpca0418)*

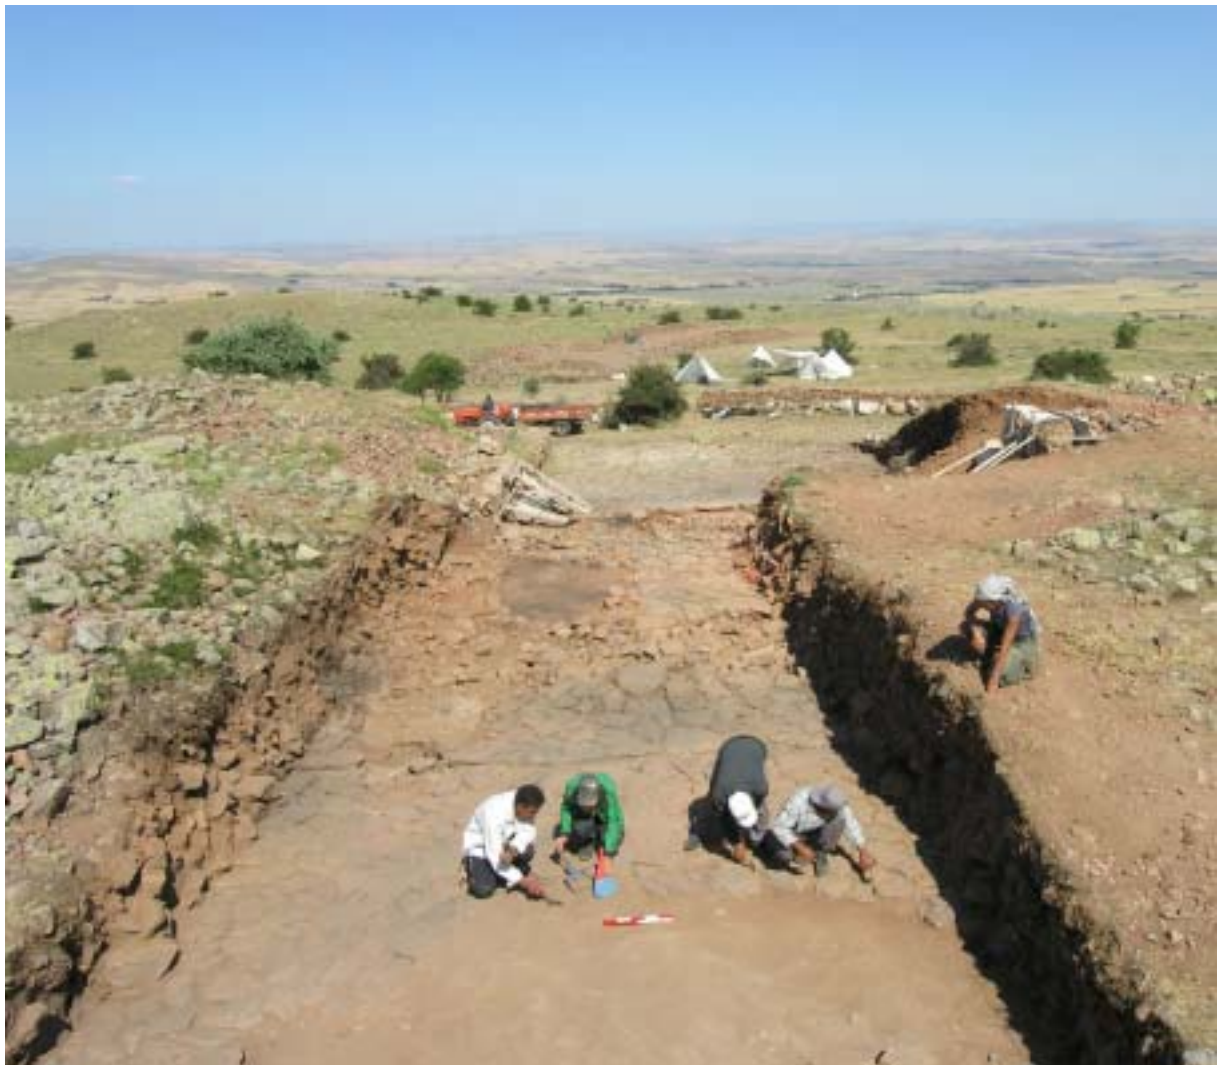
*Figure 9. Excavation of the Monumental Entrance to the Palace Complex, looking east down the passageway between the two towers. Temporary wooden shoring supported the structurally unstable walls at the front end of these massive towers. Workmen are brushing the western stretch of stone pavement extending beyond the rear façade of the monument towards the Audience Hall. (05dpnc0155)*

The focus of the summer season was excavation at the Palace Complex, which has now revealed the entire length of the Monumental Entrance (Fig. 9). The stone pavement between the front half of the two massive towers was completely exposed and the inner passageway, with evidence of both front and rear wooden façade, partly excavated. This brought to a successful conclusion the current programme of excavation, leaving the 2006 season free for final publication work and the study of finds.

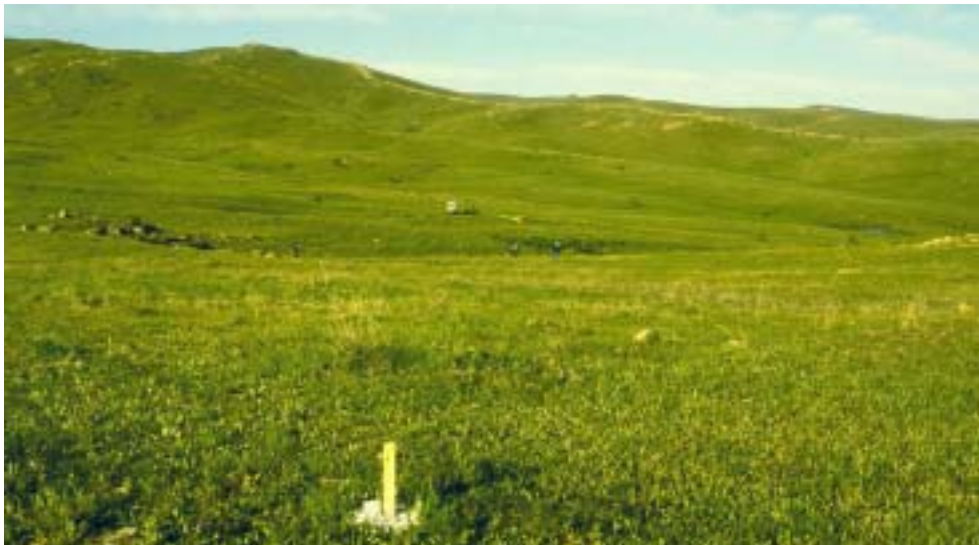
*Figure 13. Central Area with the Büyük Göl at centre right. The wooden peg marks the corner of a 20 x 20m grid. Although wooden pegs are burnt by shepherds to make tea, the white lime spot survives several years, allowing re-establishment of the grid used for the gradiometer survey. (05slvf0230)*

The Central Area (Fig. 13) has been the main target of the resistivity survey since 2001 when Harry von der Osten obtained images of outstanding quality. During the 2005 survey, the area east of the *Büyük Göl*, surveyed in 2002, was expanded on either side of the seasonal stream flowing westwards towards the main watercourse and linked to the main survey.

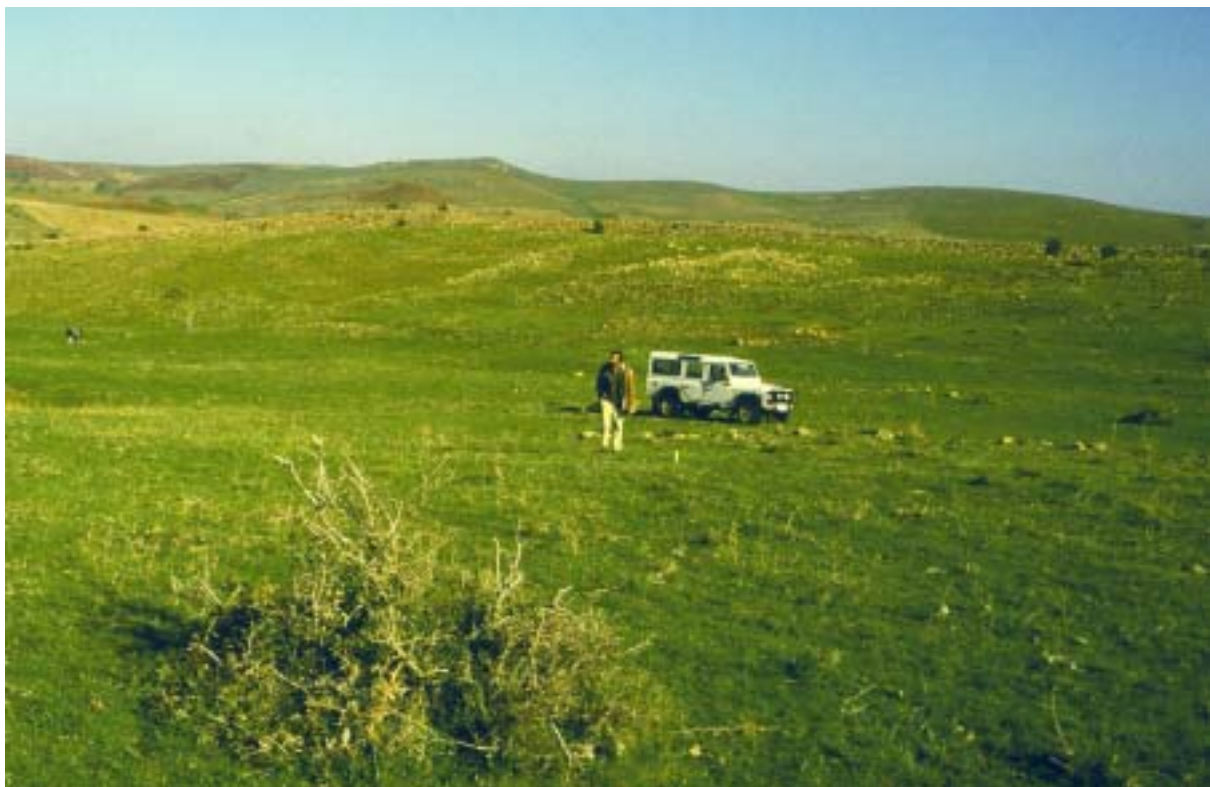
*Figure 16. Inside the north western stretch of defences where resistivity survey was carried out during the spring season. Trench TT15, dug across a large two-roomed hall in 1996, stretches down the slope from the two small bushes at upper right. (05slyf0216)*

There were three objectives to the resistivity survey at the north end (Fig. 16). Of these, the first was to obtain resistivity imagery (Fig. 17 bottom) of the large two-roomed hall and associated structures that had been investigated by excavation in 1996 (trench TT15) and 1998 (trenches TT20 and TT21). This was in order to provide the maximum amount of information concerning subsurface remains with respect to the possibility of conducting further excavation in this area in the future. In addition, it was of particular interest to see if resistivity survey would locate the twin rows of (uncut) granite bases for large wooden columns, the existence of which was demonstrated by excavation but did not show on the gradiometer shade plot (Fig.17 top). Unfortunately, neither this recent survey nor previous geophysical survey of similar large halls at other locations within the city has yielded such evidence and, therefore, the reconstruction of rows of columns has been necessarily conjectural.

The hall and anteroom (Figs 16 and 17) were shown to be 24 metres in width, needing beams or trusses to span 8 metres between two rows of columns. The building was rectangular and the hall, unusually, seems to have been square. These proportions might partly reflect the restrictions imposed by the sloping terrain and outcropping bedrock. It was also revealed that there was a wide central doorway, presumably for wooden double doors, in the wall between the anteroom and the main hall. However, in the front wall of the building no doorway can be discerned on either the magnetic or the resistivity map.

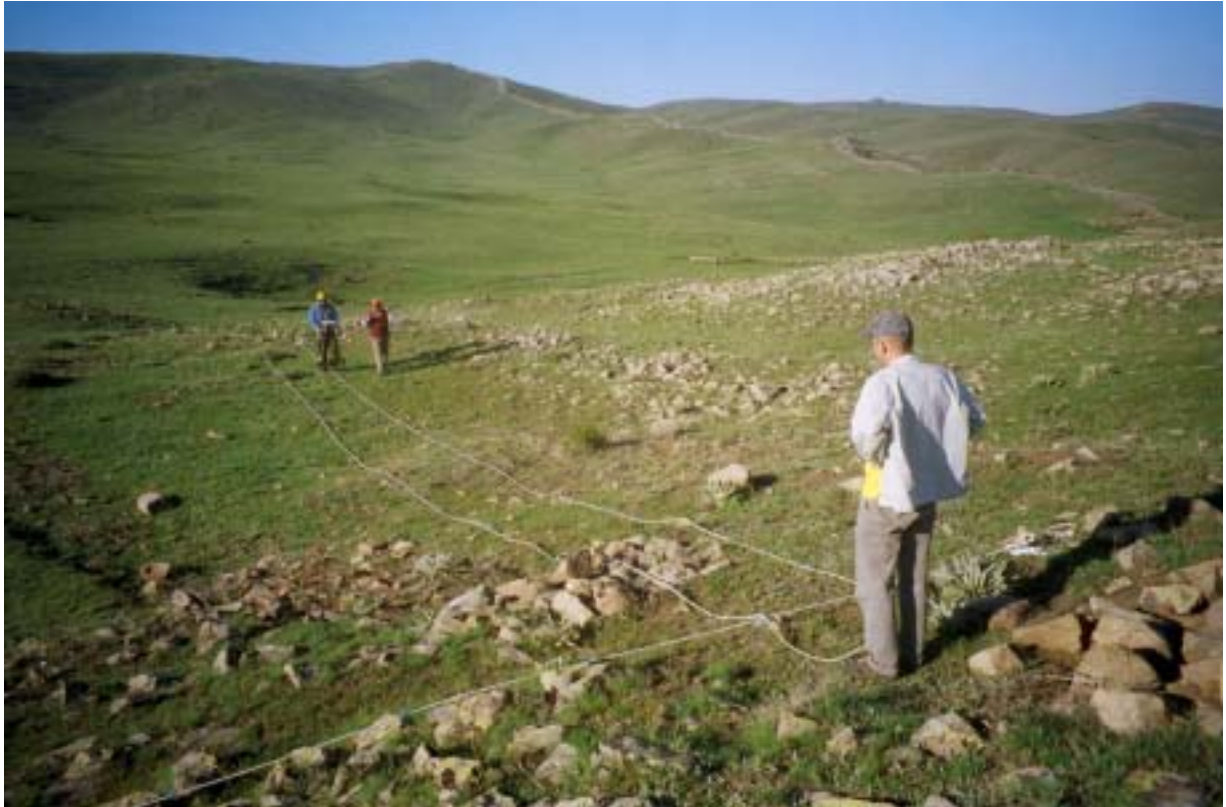
*Figure 18. Resistivity survey in progress over the large hall at the north end. The scar of trench TT15 runs diagonally across the bottom with representative Mehmet Sevim standing on it. Part of the western defences can be seen in the background. (05cnvf0217)*

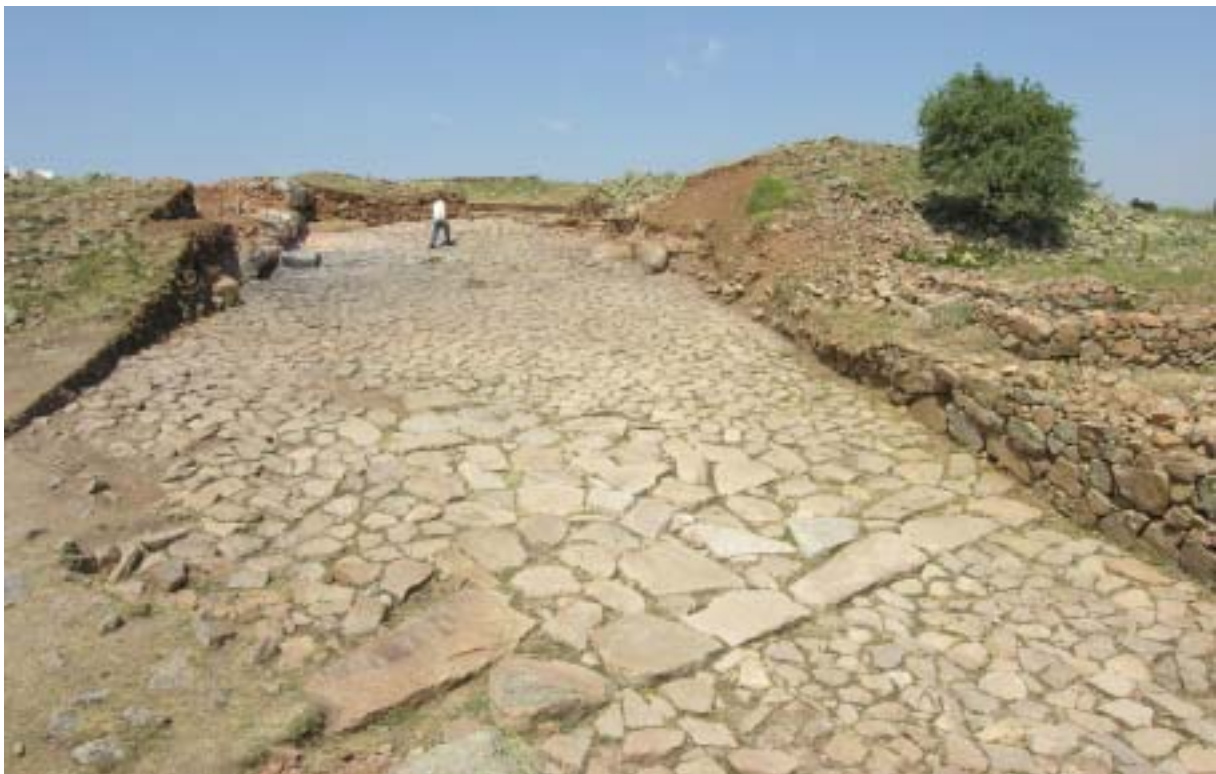
*Figure 19. Excavations at the Monumental Entrance to the Palace Complex have revealed a stone pavement leading up to the Audience Hall through a passageway between two massive towers. Scott Branting who is conducting a transportation study at Kerkenes, is seen here walking up the paved way towards the Audience Hall just discernable on the horizon at centre. (05dpnc1006)*

So as to distinguish it clearly from the seven city gates in the 7km of defences, the large and visually impressive public monument, with its two massive towers and a passageway leading towards the Audience Hall, has been labelled the 'Monumental Entrance' to the Palace Complex (Figs 19 and 20). The monumentality is obvious enough. It is undoubtedly an entrance, and thus a type of gate, so that by definition it demarcated space and controlled passage between the outside and the inside.

The report that follows represents a culmination of several seasons of survey, clearance and excavation (Fig. 19). Work on final detailed plans and architectural elevations is not yet complete. Many architectural details need to be resolved by further work on the smashed blocks now in the excavation depot. Nevertheless, the general scheme and the plan are already clear (Fig. 20). The entrance passageway, overlooked by two massive towers, is orientated east-west and the symmetry of the architecture, both in plan and in elevation, is striking. The large expanses of stone paving, leading to and beyond the entrance as well as in the passageway itself, surely indicate that it also served a variety of public functions, formal and informal.

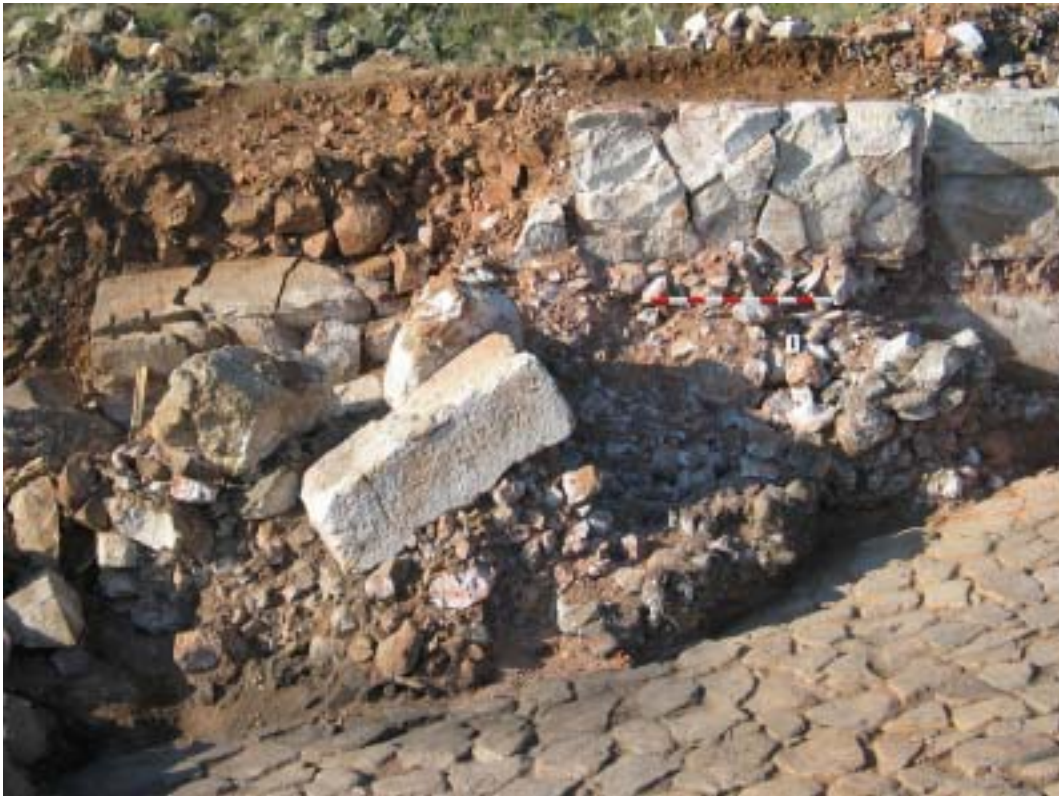
*Figure 22. Loose fill and debris were carefully examined and sorted as excavation progressed. (05dpca0224)*

The loose fill of the entrance comprised, for the most part, very loose stone rubble and debris with, immediately on the pavement, ash and patches of charred reed thatch (Fig. 22). Extensive and irregular robbing, down to and occasionally through the stone paving, was the cause of the random scattering of carved, sculpted and inscribed fragments throughout the pit fills. The fill was carefully sorted and removed by hand. Granite rubble, which made up most of the fill, was examined and discarded. Burnt and vitrified debris and large, broken and shattered sandstone blocks were stacked on the site. All other sandstone was taken to the Excavation Laboratory where it was washed and sorted. Where necessary sieves were used to extract the sandstone, but it was not possible to shake a sieve without further breaking the friable stone, so that material was sorted on perforated plastic screens. Broken and shattered architectural blocks (Fig. 23), some with bolsters or bolster-like reliefs, were recorded *in situ* before being taken to the laboratory for cleaning and reassembly. These processes made excavation slow and tedious. The extent of damage caused by large blocks tumbling from the tower wall onto the pavement combined with the loss of many architectural fragments as a result of vitrification during the fire as well as dispersal in later robber pits, hampered recognition, excavation and conservation.

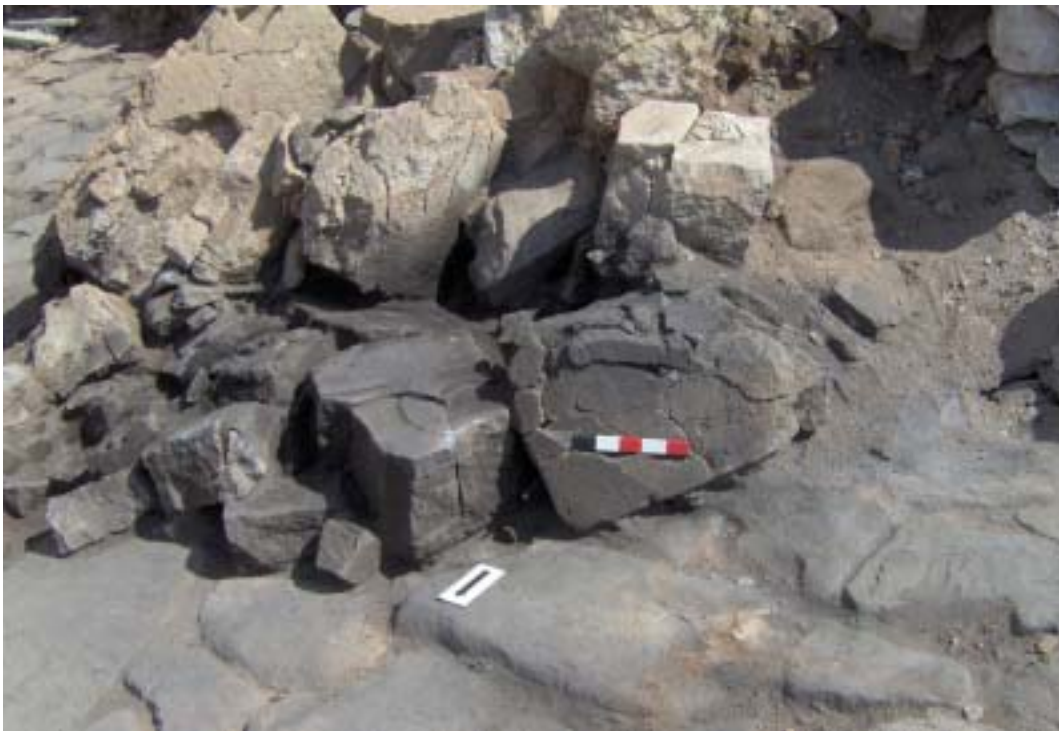
*Figure 23. Architectural blocks from the collapse of the South Tower were recorded in situ before being removed and sent to the excavation conservation laboratory. (05dphp1122)*

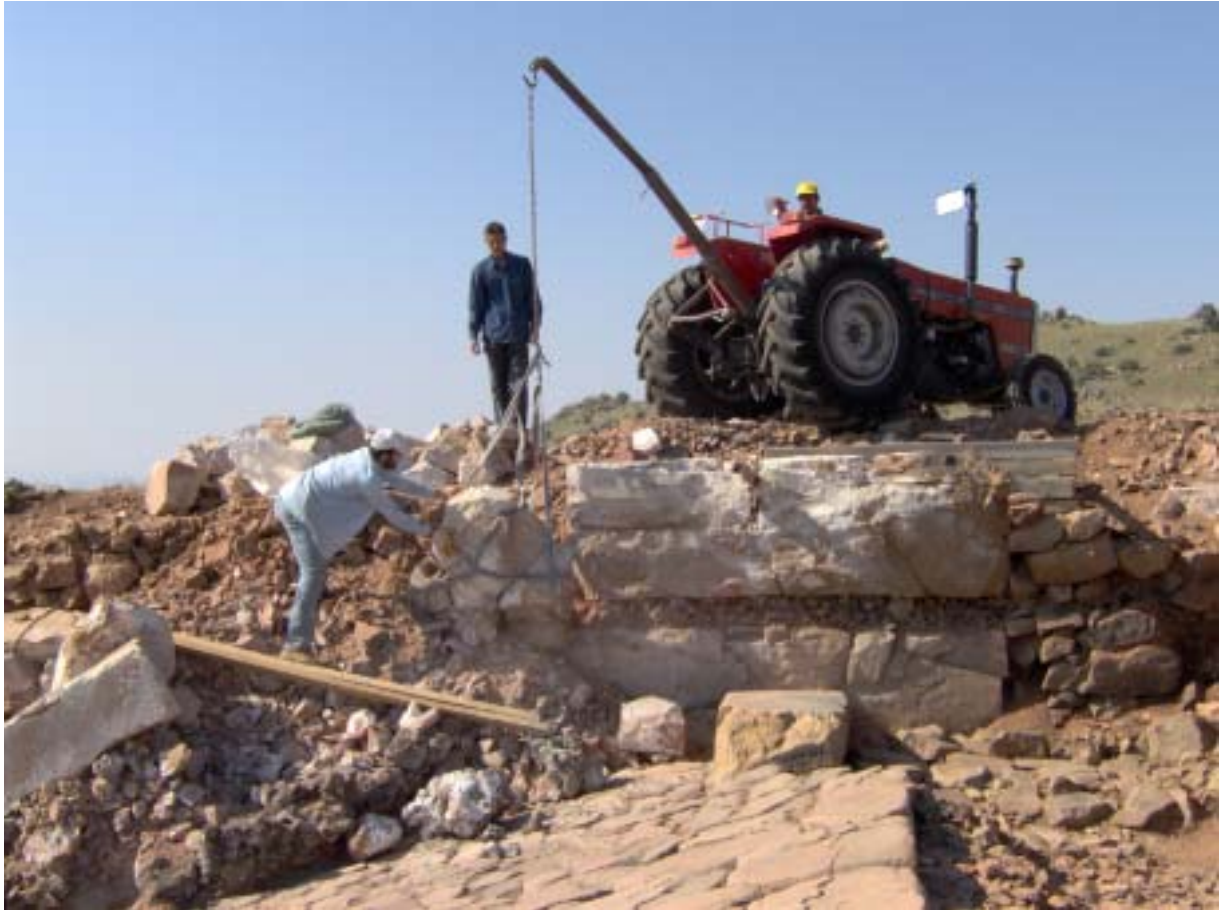
*Figure 24. The horizontal gap left between courses after the horizontal beam completely burnt down caused the wall of the South Tower to become structurally unstable. Facing blocks and burnt debris are naturally coated with white carbonates. Many of the large stones, shattered by the intensity of the fire, had to be removed for safety. (05dphp1104)*

While it may be said with confidence that nothing of importance was missed, it is sad to report that the intensity of the fire had so broken the masonry of the passage walls that very little remains *in situ*. The horizontal gap left between courses after the horizontal beam completely burnt down caused the wall of the Towers to become structurally unstable. Many of the large stones shattered as the result of the intensity of the fire had to be removed for safety. As a temporary measure wood was used to prop up what remains of wall facing, but this has been done for safety pending implementation of a conservation and restoration program.

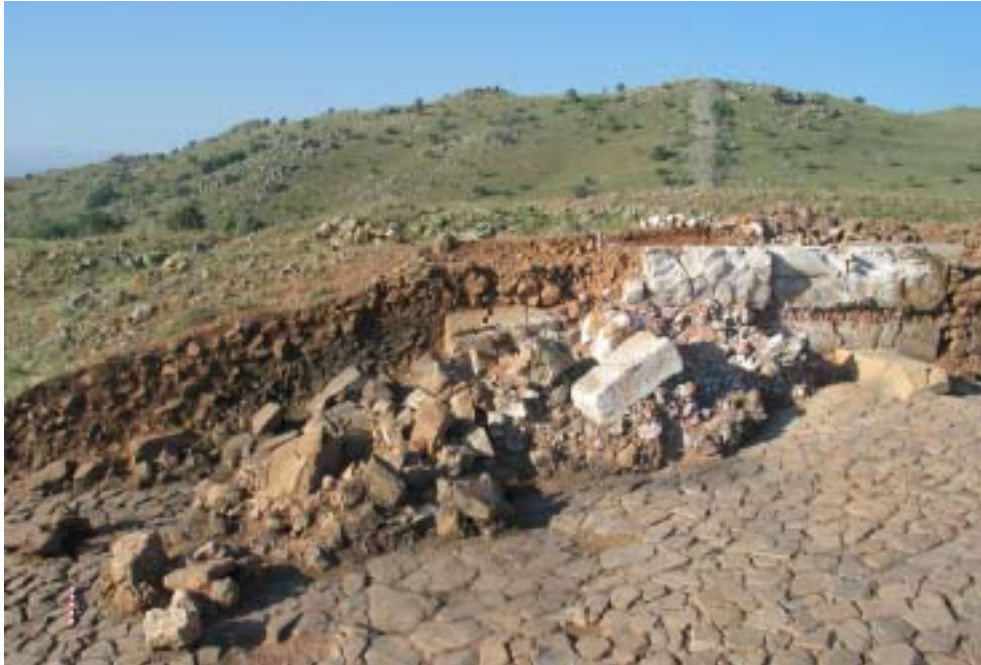
*Figure 25. Remains of the South Tower before removal of the collapse which had buried the column base. Part of the city defences can be seen in the distance at right. (05dpca0214)*

An architectural scheme of remarkable symmetry boasts a monumental entrance between two massive towers (Fig. 25 and 26). Nothing can be seen of the internal arrangement and floors of the towers, the core of each having been extensively dug into by robbers. A large column base, adjacent to the front end of the tower walls, stands proud of the sloping pavement on either side of the passage.

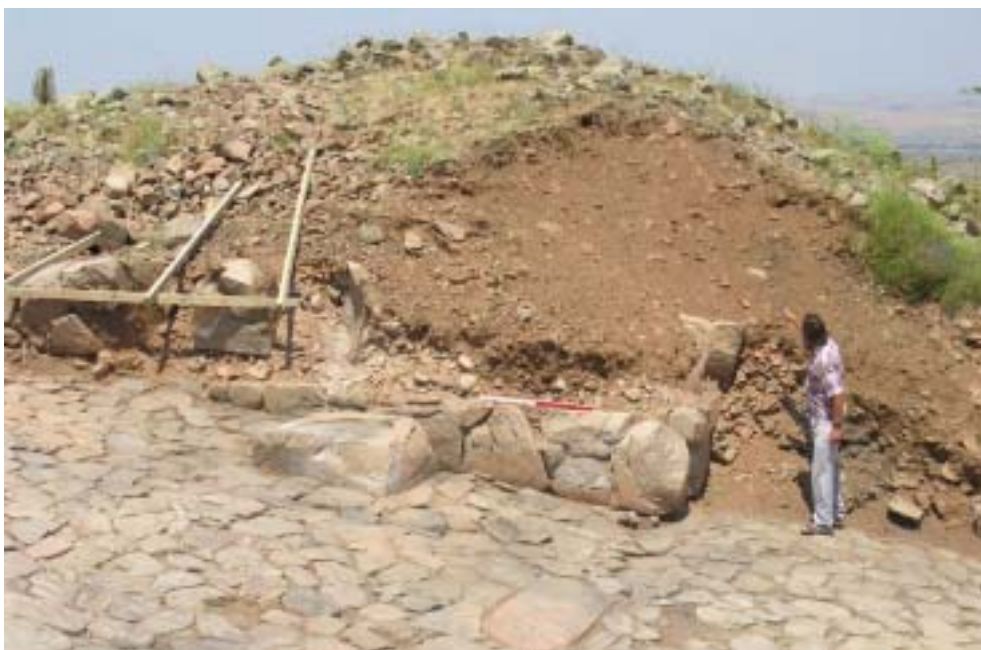
*Figure 26. The North Tower where leaning upper courses of large but shattered granite blocks did not survive. The column base seen here was uncovered in 2003. (05dpnc0964)*

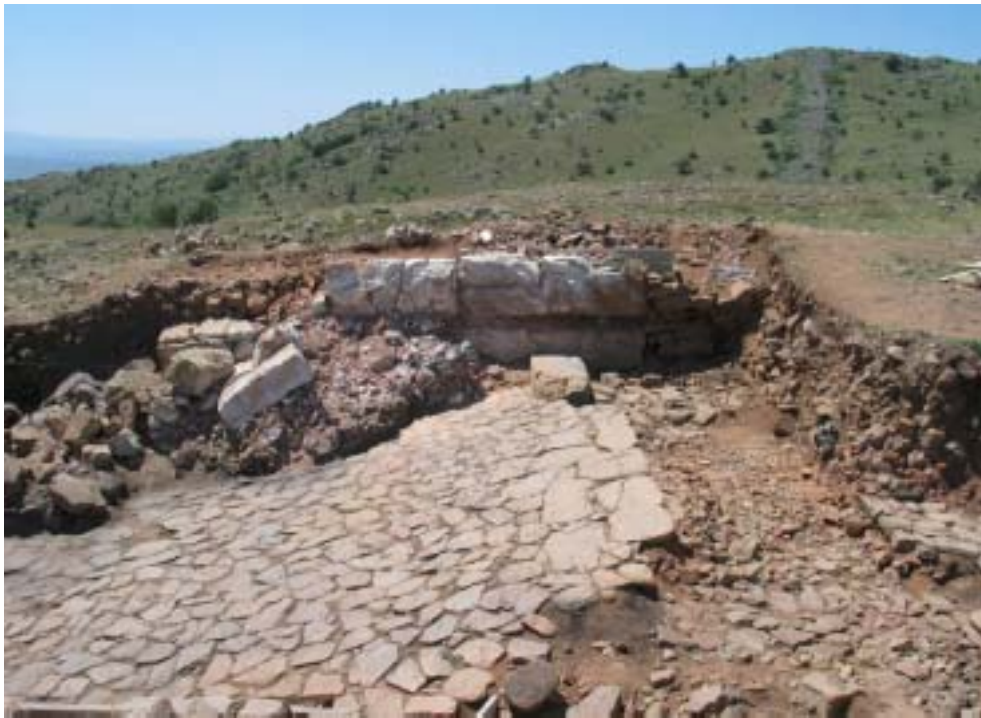
*Figure 29. Excavations at the Monumental Entrance looking south and showing collapse from the South Tower, the conglomerate plinth and the foundation trench for the front façade. (05dpca0152)*

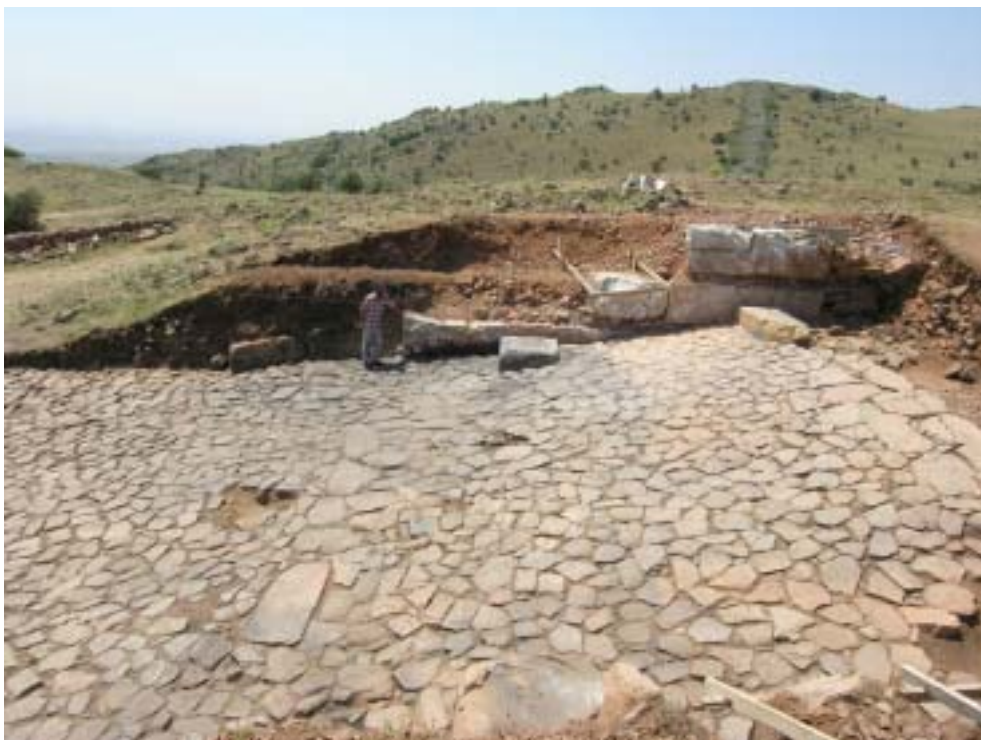
*Figure 30. The stretch of stone pavement between the front half of the two towers is 10.50m wide and the two column bases stand 9.20m apart from centre to centre. Beams between the courses of huge cut blocks burnt out completely, causing the wall to fracture and collapse. (05dpnc0862)*

The front half of the broad passage, which is inclined at a gradient of approximately 1 in 5, is paved with granite worn to a polish (Fig. 30). Setting lines in the portion of pavement in front of the towers are not parallel to the orientation of the entrance but lead to the doorway of the Audience Hall (Figs 20 and 27), demonstrating that the original pavement and the Audience Hall pre-date the construction of the Monumental Entrance. At the inner front corner of each tower the top of a foundation stone can be seen slightly above the level of the top of the pavement and projecting in both directions for a few centimetres beyond the line of the upper walling. This slightly wider footing appears, however, to be restricted to the corner stones and is not observed along the tower walls rising up the passage slope (Fig. 31). The square sandstone column bases on either side, set back c.2.05m from the front of the towers, have shallow circular recesses c.0.85m in diameter. In all probability these were for tall, freestanding wooden columns provided with sandstone capitals (although an alternative possibility is discussed below). These bases were shaped in position, as was the rectangular conglomerate plinth preserved at the southwest corner of this front portion of the entrance. The plinth, measures 2.10m by 0.70m and was presumably mirrored by another one on the opposite side of the door. From the front of the towers inwards the paving was re-laid up to the walling, column bases and the, presumably two, plinths. This may be demonstrated by the row of particularly large stones along the line of the tower fronts.

It is now thought that this front section of the Monumental Entrance was unroofed for several reasons. Firstly the span, while not impossible, seems very wide, particularly as there was only a single pair of columns. Secondly, the steep slope of the pavement would have made roof construction difficult. Thirdly, if it is correct to reconstruct a large timber façade founded in the wide slot at the top of the slope any roof would have obscured it from view. Lastly, it would seem that the distribution of burnt debris, in as far as it could be ascertained between the robbing pits, is perhaps more consistent with burning of the façade and double doors than that of a passage roof. The fragments of burnt roofing, including pieces of clay with reed and wood impressions as well as deposits of charred reeds most probably fell into the entrance passage from the towers on either side.

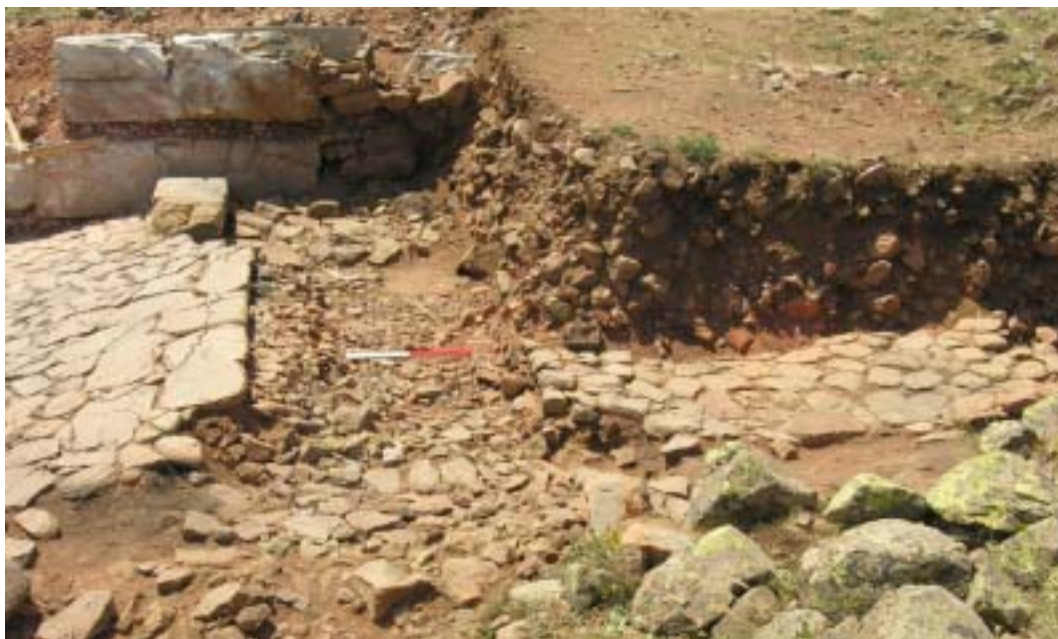
*Figure 32. The foundation slot for the front façade with the large pavers indicating the position of the double door. The large blocks of the tower wall give way to small uncut masonry where it was hidden by the partition. The 1m scale lies on rubble left after the burnt and vitrified debris were removed. (05dpnc0910)*

Approximately half way along the side of the towers, a 2.20m wide slot appears to be a foundation trench to a structure which has been described as the front façade (Fig.32). The burnt and vitrified debris and perhaps some traces of vertical posts indicate a timber frame structure with infill rubble and mudbrick.

An absence of ash and charcoal in the wide foundation slot, which was filled with masses of fused stone rubble and mud that most probably came from the upper walling of the towers as well as the core of the façade itself, suggest that the doors and possibly much of the partition itself may have been pulled down before the fire. Additional evidence that the doors were pulled out prior to the burning came in the form of fragments from a small sandstone bolster recovered from the hole for the southern doorpost.

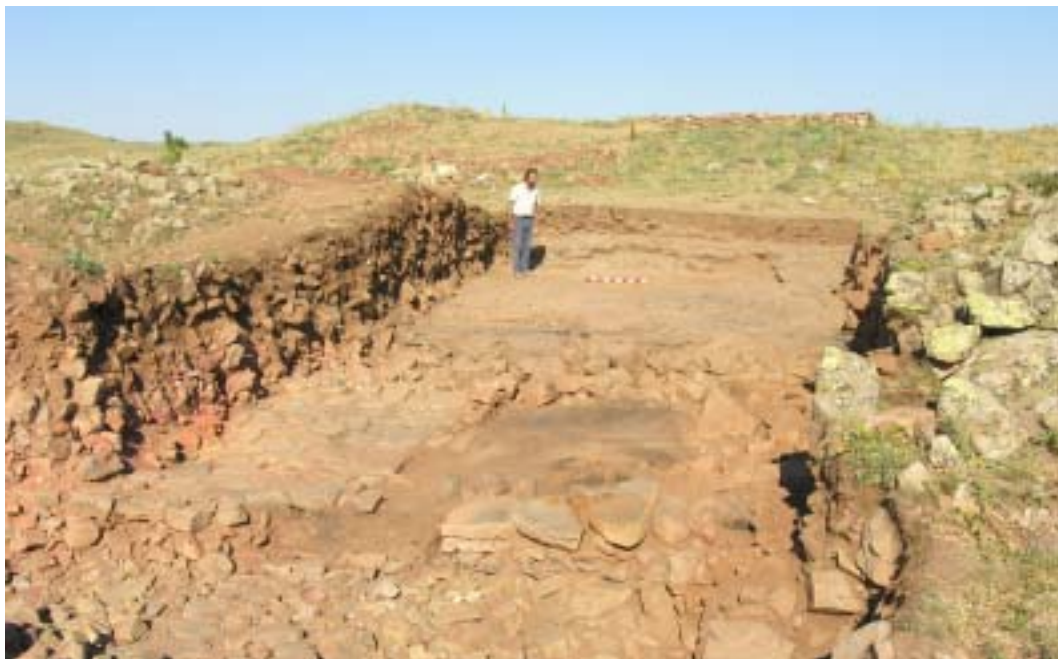
*Figure 33. The excavated half of the inner portion of the entrance, between the front and rear façade. A burnt clay floor indicated the location of a small room in front of which was a bin like feature. The 1m scale is on the western stretch of pavement leading to the Audience Hall that can be seen in the background. (05dpnc0209)*

Passing through the double doors of the front façade led to a second paved and levelled area where the paving stones are smaller and exhibit less signs of wear (Fig. 33). A burnt clay floor indicated the location of a small room in front of which was a bin like feature. As suggested on the plan (Fig. 27), it is reasonable to assume that there was a symmetrical arrangement and a room on the unexcavated southern side mirrored that on the north. No alterations were made to either this portion or to the rear section of the entrance before the destruction.

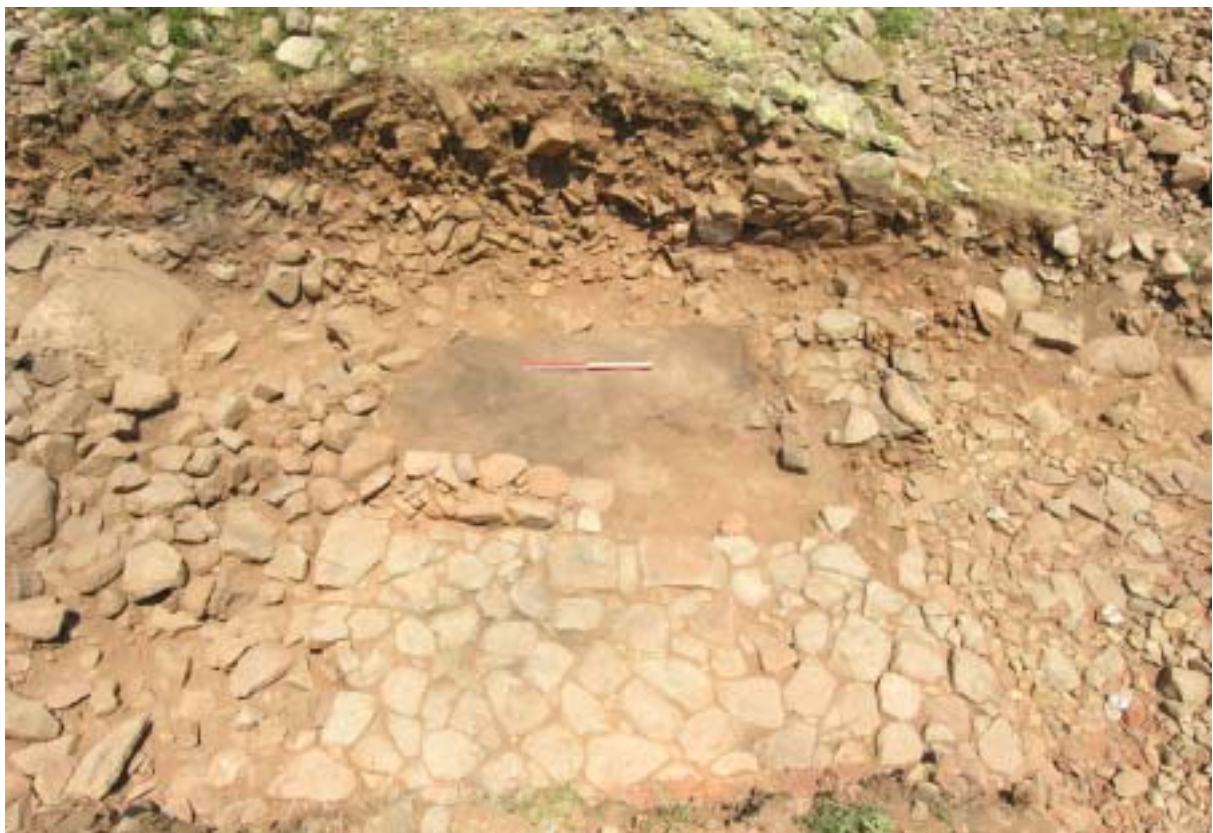
*Figure 34. In 2004, excavation revealed a small room with a clay floor and an open stone paved inner portion of the entrance. These elements of the Monumental Entrance were only fully understood in 2005 when excavation extended westwards to reveal evidence for a rear façade. (05dpnc0941)*

A slightly raised step was found in front of the doorway of the room on the north side (Fig. 34). This featureless room was provided with an earthen floor. The awkwardly narrow space between the east end of the room and the partition was lined with a single course of stone above the pavement forming a shallow bin-like feature.

The room and, and its presumed twin, were obviously roofed. Since no roof debris was recovered from the extant floor of the room it can be assumed that the roof comprised reed thatch which had been reduced to ash. In keeping with common practice at Kerkenes it is probable that the central paved area was open, a suggestion reinforced by the raised stones in front of the door and the absence of burnt roofing remains on the pavement.

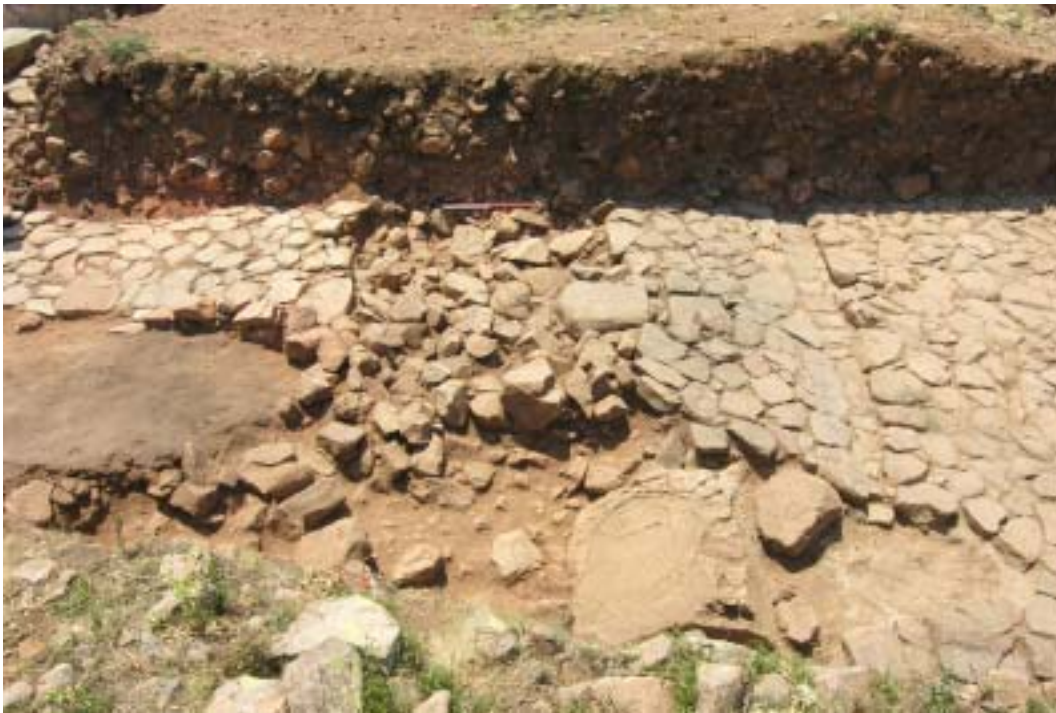
*Figure 35. Looking south along the excavated half of the rear façade. At left the clay floor of the small room shows signs of intense burning. At right, a robber's pit disturbed the drain carefully set into the stone pavement and the column base which now leans into the foundation slot for the western façade. (05dpnc0917)*

The rectangular inner passage was enclosed at the rear by another façade (Fig. 35) similar in many respects to the front façade described above. It can be supposed, although not certainly demonstrated, that double doors stood in the centre of the rear façade. The presence of a fallen granite stele of truly aniconic form (Fig. 36) set up behind a sunken square granite stone with a finely worked upper surface supports this suggestion. It is assumed that the west wall of the inner room stood close to the back of the façade structure. Robbing had, however, removed all evidence.

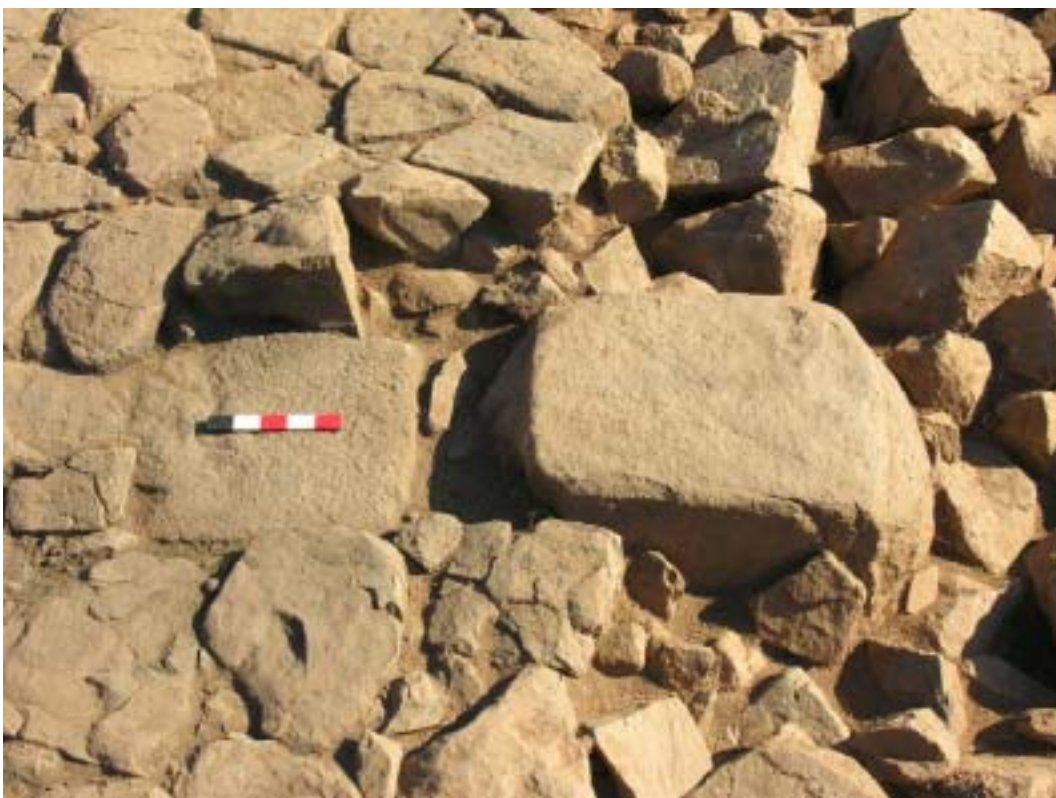
*Figure 36. A fallen granite stele of truly aniconic form set up behind a sunken square granite stone with a finely worked upper surface. The scale is 25cm. (05dpnc0219)*

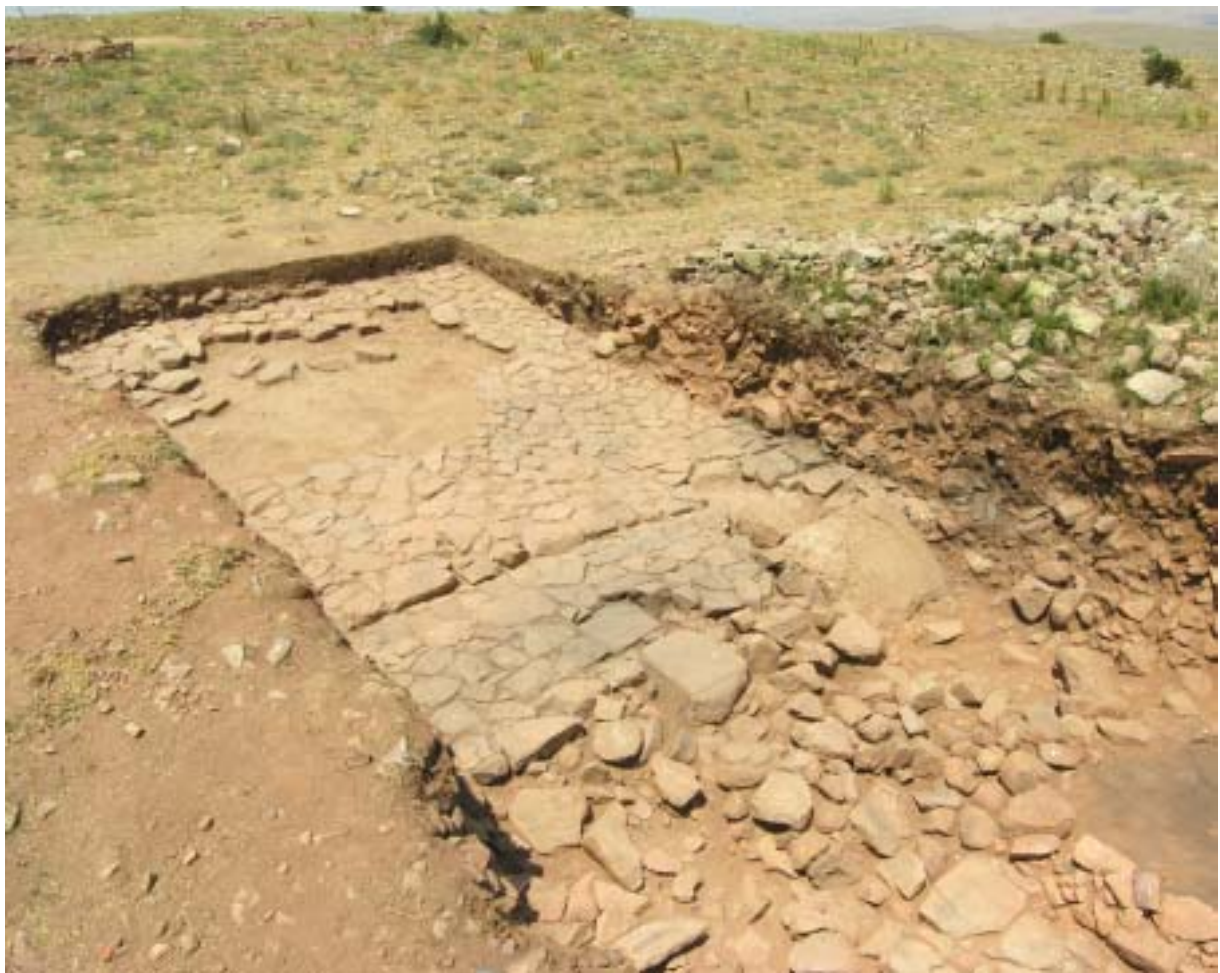
*Figure 37. Excavations at the Monumental Entrance to the Palace Complex looking northeast, showing the pavement with drain, the displaced sandstone column base at the back of the entrance and the fallen aniconic stele which would have stood erect by the side of the door. (05dpnc0943)*

An area of stone pavement (Fig. 37), partly robbed, extended towards the Audience Hall. A drain set into the pavement along the rear façade took surface runoff away from the entrance in a northerly direction. The portion of this drain that runs across the front of the entrance was more neatly and regularly built than its northern end (Fig. 38).

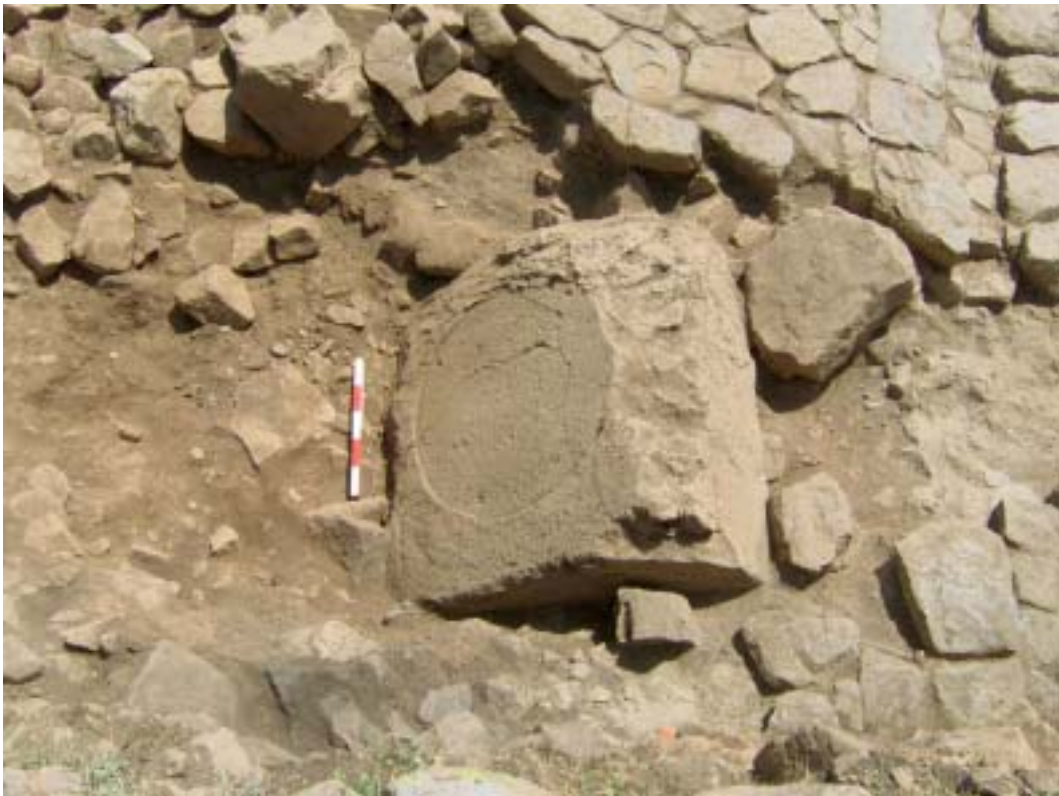
*Figure 39. A square column base with a circular recess for a wooden column was found tilted into a robber pit. (05dphp2116)*
