# **THE KERKENES PROJECT**

## **A PRELIMINARY REPORT ON THE 2005 SEASON**

**Geoffrey and Françoise Summers**

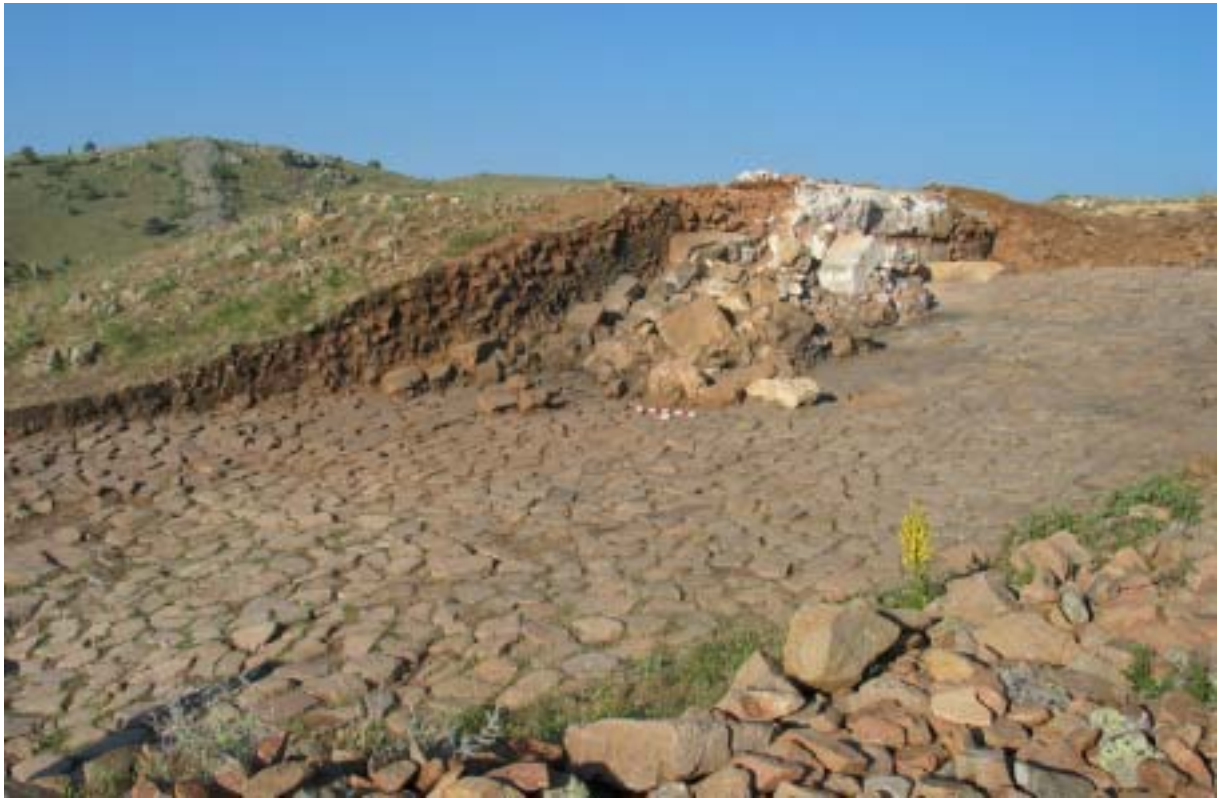
*Figure 40. Collapse from walls of the South Tower of the Monumental Entrance was removed in the course of the 2005 excavations. (05dpca0206)*

In plan, the towers are rectangular and each measure approximately 15.60m by 13.00m. The position of the rear face has not been exactly ascertained, precluding precise determination of their length. The corner of the South Tower was exposed after the collapse (Fig. 40) was carefully recorded and removed. Little was done by the North Tower apart from cutting back further the dangerously loose edge of the excavated area (Fig. 41).

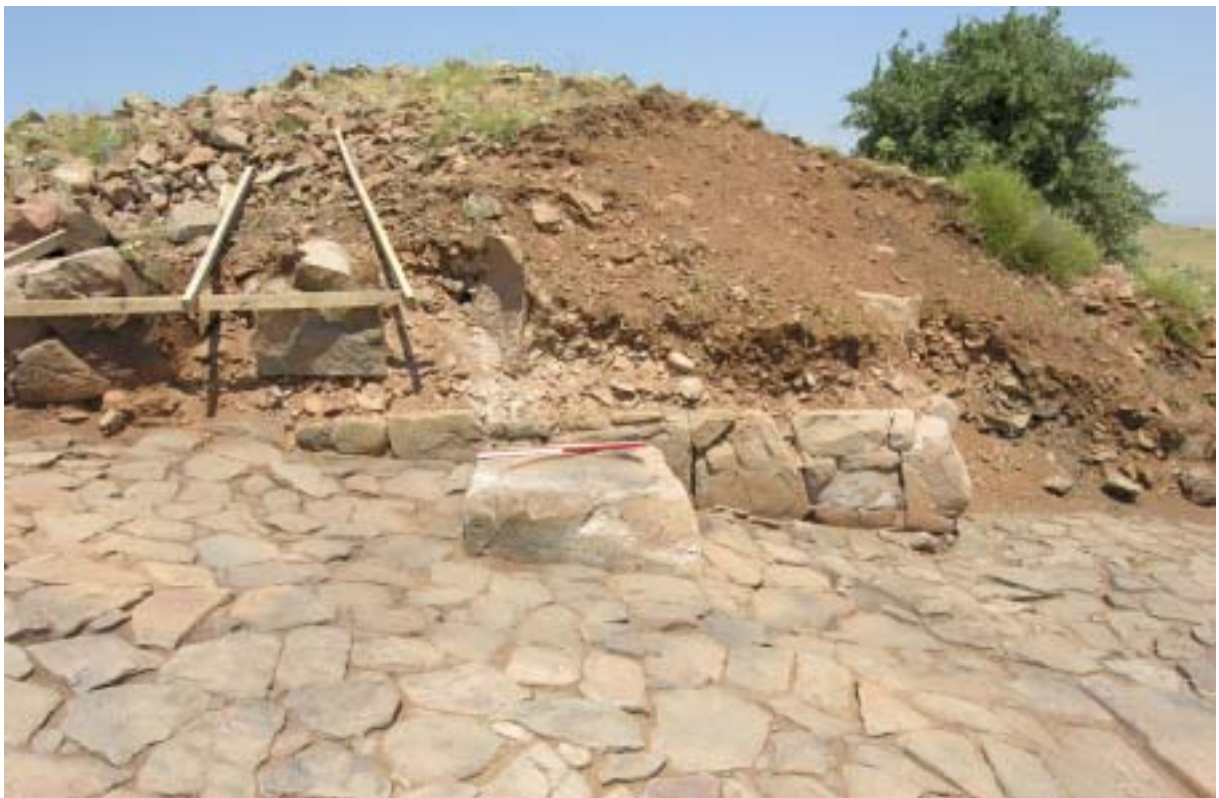
*Figure 41. Only the lower course of the walls of the North Tower was stable enough to remain in situ. The scale on the column base is 1m long. (05dpnc0967)*

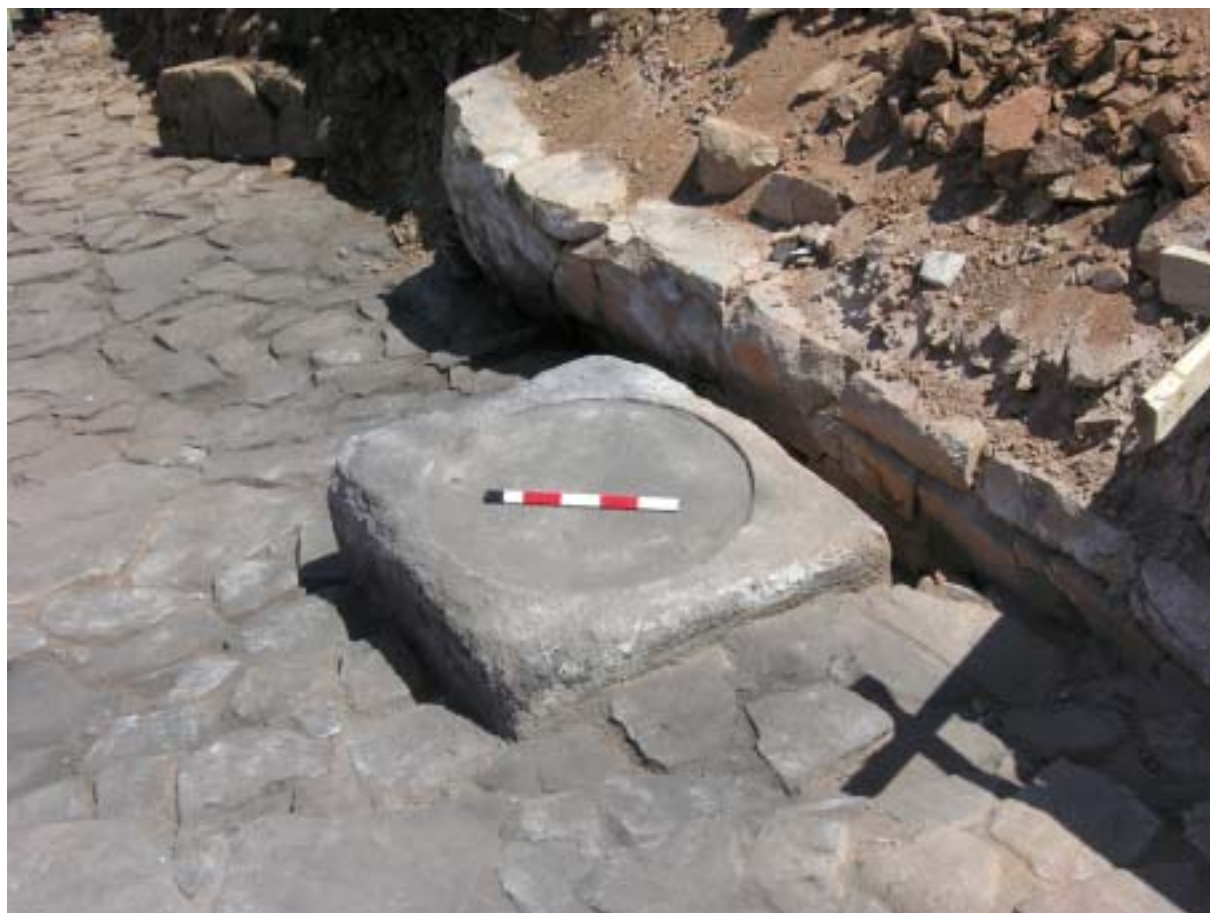
*Figure 42. The inner corner of the South Tower with the column base set in the sloping pavement. (05dpnc0516)*

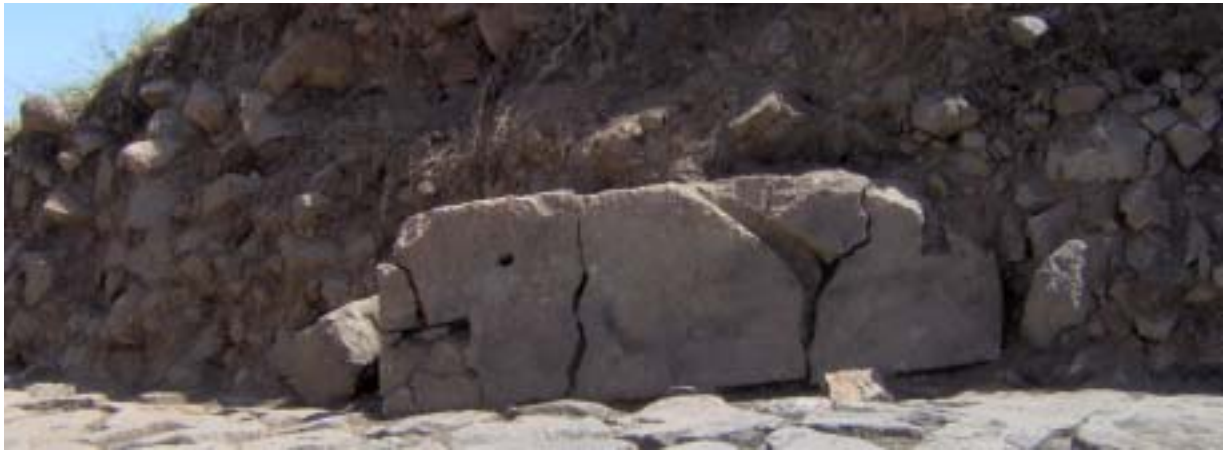
*Figure 43. Clamp cuttings on a block fallen from the South Tower. (05dphp2111)*

An important detail, not least for the chronology, is the use of wooden swallow-tail clamps, the charred remains of one having been recovered in the cutting itself. Small neatly carved clamp cuttings were recorded on the two large, faced, granite blocks, that stood on the northeastern corner of the South Tower and the adjacent block to the west. These smoothed clamp cuttings were for mending granite blocks that had broken during construction. In the sandstone, by contrast, there were numerous swallow-tailed clamp cuttings. There were deeper, not particularly regular and rather rough clamp cuttings, exhibiting considerable variation in size, in the sandstone (but not apparently in the soft limestone). They appear to have been cut with the same tools as were used for shaping and finishing the sandstone and limestone blocks (but not the much harder granite), and essentially these appear to be woodworking adzes and chisels. Clamps were used to join adjacent blocks in wall faces and, at 45° angles, to brace blocks on tower corners (Fig. 43). In addition there were, as reported last year, clamp cuttings that perhaps secured facing blocks to floor joists. It can be argued that the beams were floor joists rather than timber lacing within the core of the tower since in the latter case some evidence of charred timbers would have been recovered.

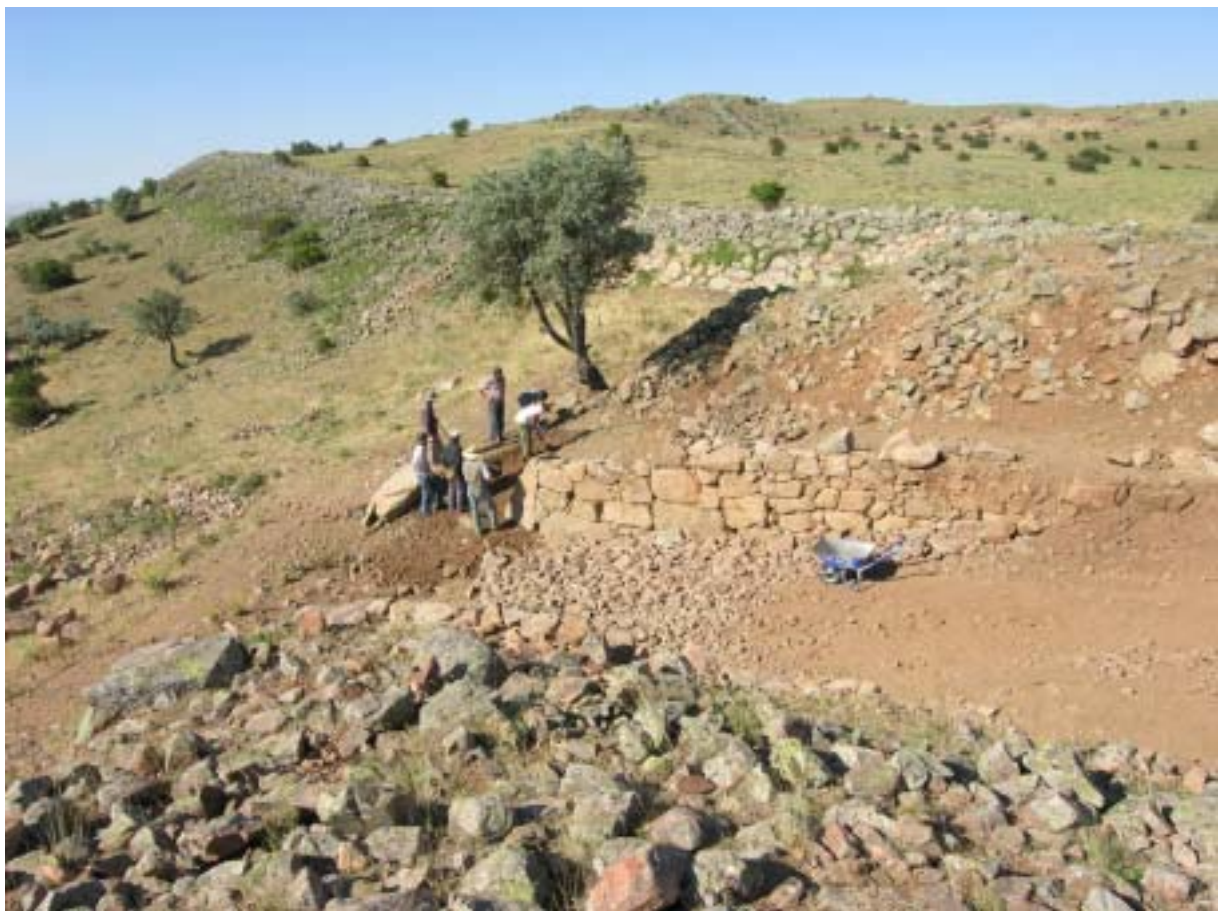
*Figure 44. 2005 work at the Cappadocia Gate concentrated on visual enhancement and safety. (05dpcn0404)*

Collapse of the section cut across the passage of the Cappadocia gate in 2002 as well as erosion that was continuing to undermine the northwest wall of the passage made it desirable to ramp down the passage fill (Fig. 44). This course of action not only made the entire gate visually more attractive but it also enabled measures to be taken that route human and animal traffic through the original passage rather than by the modern track that traversed the southwest tower. Visual enhancement was further improved by revealing the topmost surviving part of the glacis in front of the southwest tower which had been covered by the track. The original passage surface, which still retains fragile traces of the fire which brought the life of the city to a close, has now been preserved beneath a layer of rubble which has also covered the base of the passage walls. At the same time the uppermost intact courses of the passage walling have been, for the first time, exposed over their entire length.

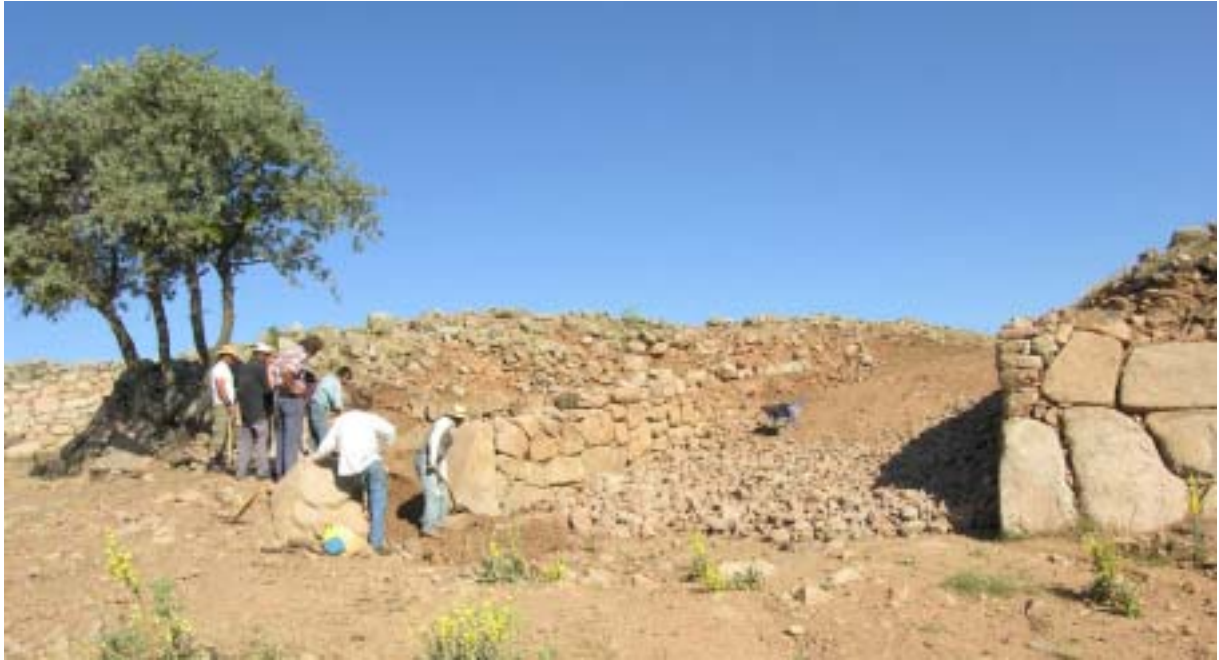
*Figure 45. Visitors can now walk through the 6m wide passageway. (05dpnc0408)*

For most visitors, the Cappadocia Gate is one of the highlights of their visit (Figs 45 and 46). It has however been decided that no further work can be undertaken at the Cappadocia Gate until and unless there is a comprehensive program that would involve the insertion of scaffolding and props followed by a dismantling and rebuilding of the wall faces of the passageway and the internal chamber. Such a plan of action would not only require engineering expertise and very considerable financial resources, but would also require agreement concerning the ethics and principles of restoration.

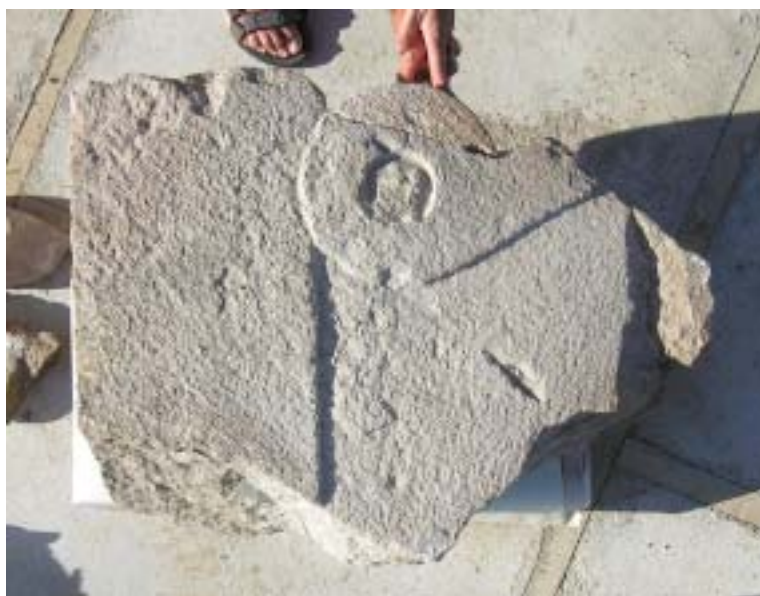
*Figure 47. Large carved block with raised margin, roundel and diagonal band which might indicate the angle of roof pitch. (05dpnc0176)*

A number of large carved sandstone elements were recovered amongst the collapse that most probably fell from the northeast corner of the South Tower. It can now be understood that the southeast corner of the North Tower must have been provided with matching elements of which few fragments survived. While it is clear that the general scheme included bolsters and bolster like elements, more work is needed to reassemble broken fragments before a convincing reconstruction of the architectural scheme can be finalised. Some of these blocks bear “masons marks” that resemble (single) Old Phrygian letters. A large block (ID 05TR17U12arc11) has a raised edge band and a circular feature at the end of a diagonal band (Fig. 47) which is thought to indicate the angle at which a roof or pediment was pitched.

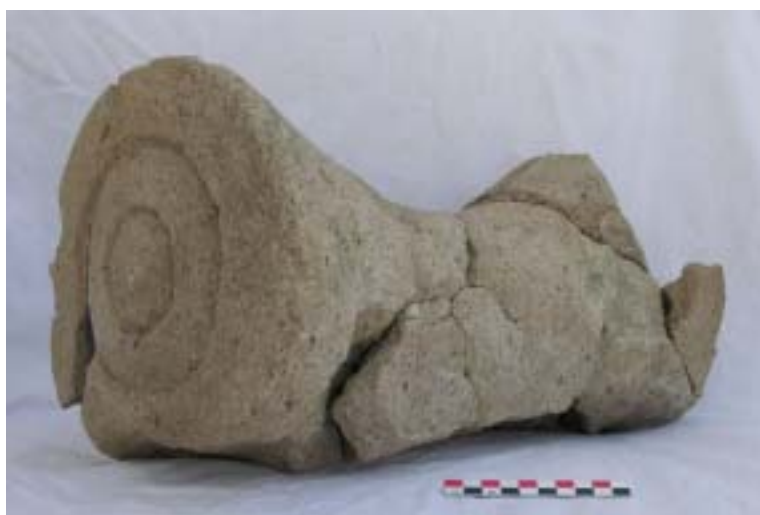
*Figure 48. Large sandstone architectural bolster, ID 05TR17U12arc07, perhaps broken from a capital to wooden columns. The scale is 10cm. (05dpnc2025)*

Large sandstone bolsters (e.g. Fig. 48 for bolster ID 05TR17U12arc07), all fragmentary, very probably broke off from the edges of sandstone capitals to the freestanding wooden columns at either end of the entrance. The estimated number of these bolsters is not inconsistent with a total of four such capitals each having a pair of bolsters or, just possibly, four bolsters on each. Joining of the many fragments is still in progress and it is hoped that it will prove possible to restore completely the precise form and size of these capitals, if such they are, at least on paper.

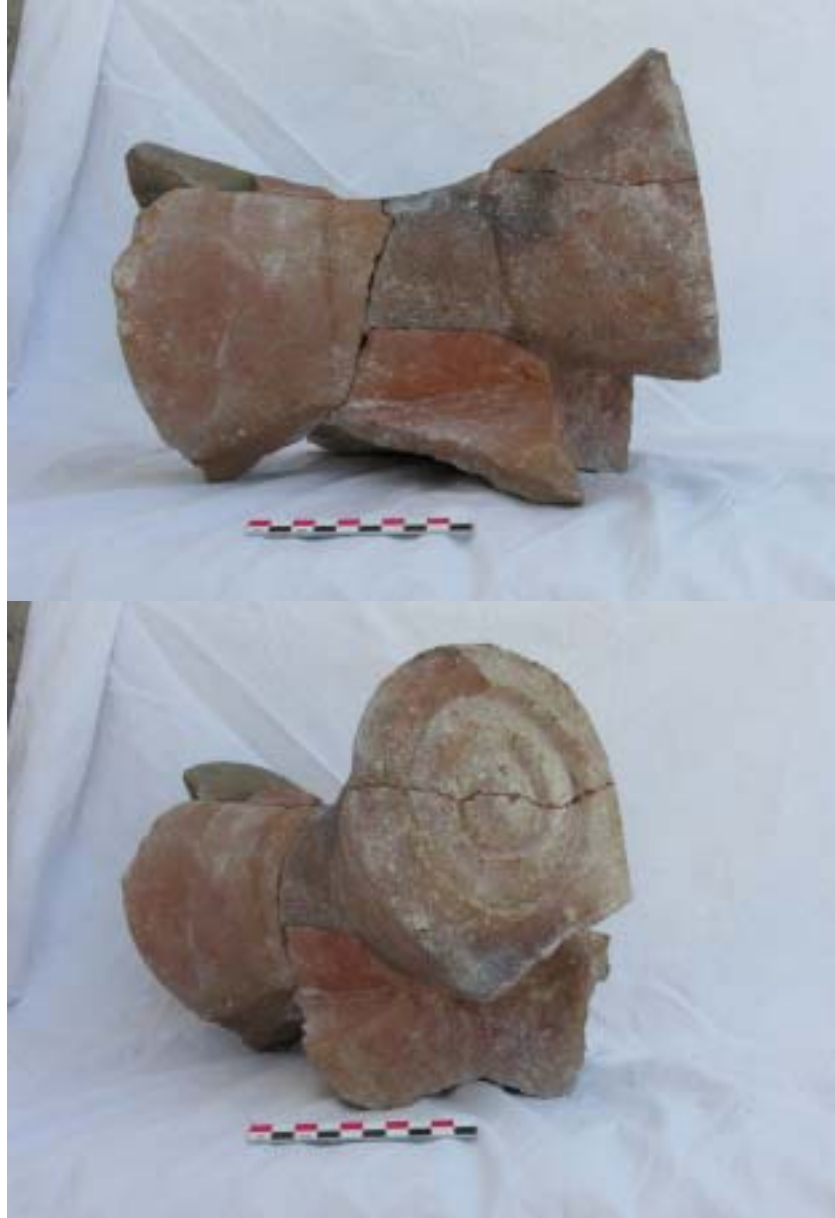
*Figure 49. Side view (above) and end view (below) of a medium-sized sandstone architectural bolster, ID 05TR16U14arc04, recovered from the collapse of the South Tower. The scale is 10cm. (05dpnc2019-20)*

Sandstone bolsters (e.g. Fig. 49 for bolster ID 05TR16U14arc04), in addition to those mentioned above, were found in a variety of sizes. It would seem that some of these and very possibly all except the small examples that belong to a square element from a freestanding monument illustrated in previous reports, appear to have come from the walls of the towers.

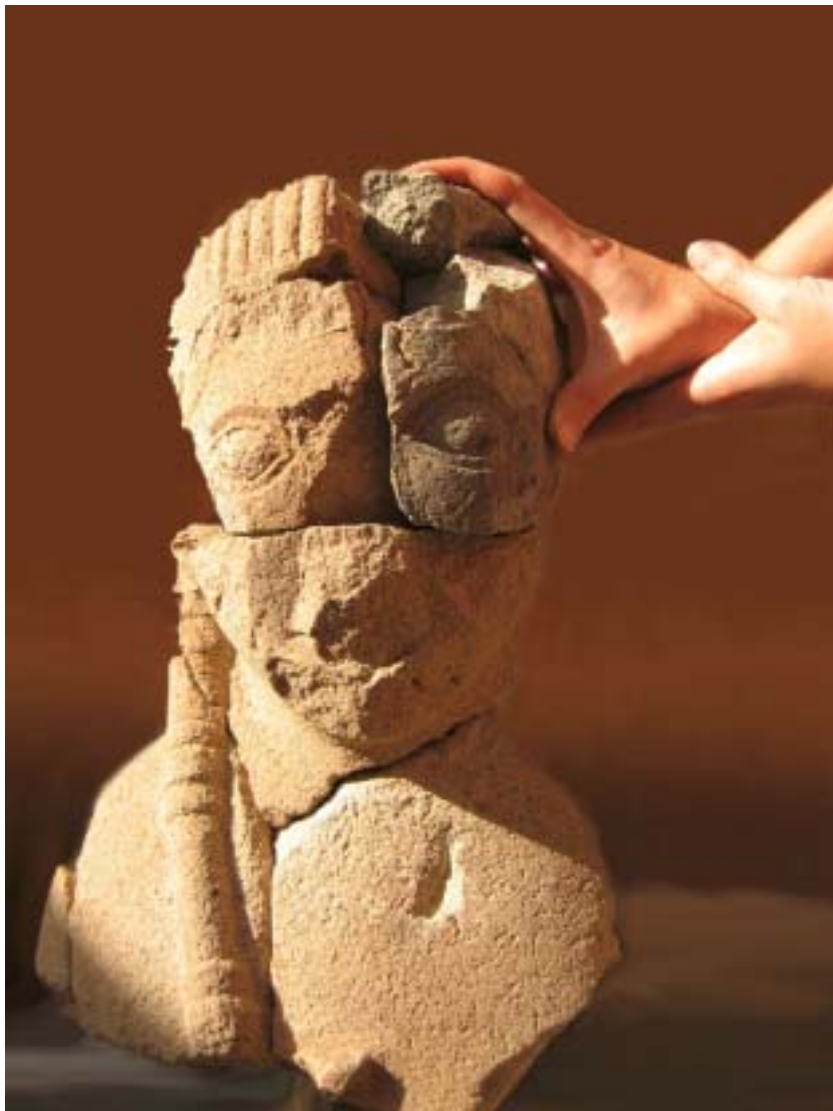
*Figure 50. Head of statue, K04.182 with ID 04TR16U02stn01 and several joining fragments. The missing left eye, ID 05TR17U14stn01, was recovered in 2005 from beneath the burnt debris by the South Tower of the Monumental Entrance. (05dpcs0421)*

More positively, the left eye (Fig. 50), together with other poorly preserved fragments from the head (ID 05TR17U14stn01), were found laying directly on the stone pavement below the remains of burnt thatch probably fallen from the tower roof. This context makes it certain that statue was smashed in the entrance passage before the fire, increasing the likelihood that it originally stood no great distance from where it was found. More negatively, neither the left arm, which seems to have been somehow extended away from the body, nor the top of whatever was held over the right shoulder have been found. Thus neither the gender nor the identification have been ascertained. In another development, it is now thought that the small steeply inclined hole in the side was probably intended to affix the figure to the large squared wooden dowel that was inserted into the lower quarter of the statue. One suggestion is that lead was used for this purpose, pieces of molten lead having been found in the destruction debris; but if so not a trace now remains. It is possible that further joins will be made, but unlikely that they will add to our understanding of this enigmatic and forceful portrayal.

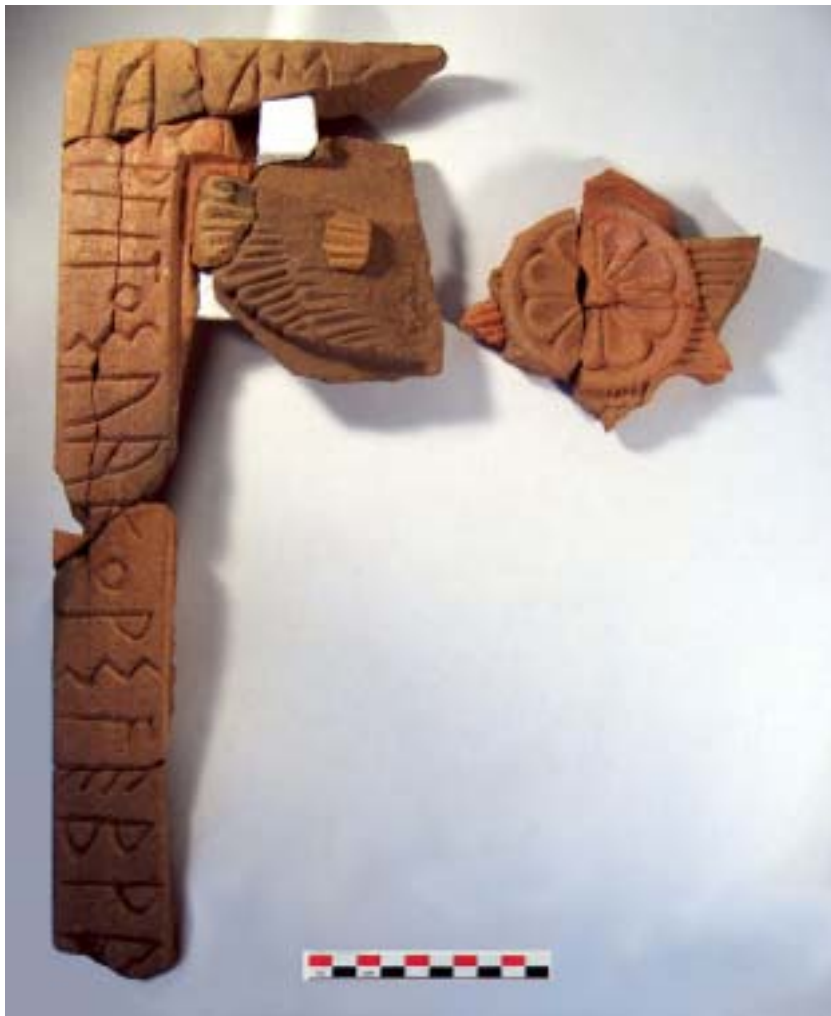
*Figure 51. Part of the inscribed and sculpted sandstone monument, K03.168 with ID 03TR11U08stn02 and several joining fragments, showing new joins made in 2005. (05dpcs0921)*

Study of the freestanding block bearing panels of small-scale relief sculpture with Old Phrygian inscriptions on some of the raised borders (Fig. 51) continued during the summer. New joins between previously excavated fragments have permitted a much better understanding of the original scheme. It is now known that the block (K03.168 with ID 03TR11U08stn02 and several joining fragments) was rectangular in profile and probably square in plan.

The main panel on the front seems to have depicted two clothed figures facing one another beneath a winged sun-disc. It is probably that these figures were griffin-headed genii. The inscription runs around the four raised borders of the front. A shorter inscription on the left side of the block (when viewed from the front) names the dedicant, Tata. Lions seem to have adorned the side panels and somewhere there was vegetation. It is not clear if the back side of the block was also sculpted. We look forward to Professor Claude Brixhe's study of the text with bated breath. The sandstone block from which these fragments of inscription and relief had sheered off has not been found and, to compound matters, there are some fragments so distorted and vitrified by the fire that, although they appear as though they may have been part of the piece, no form or inscription can be discerned. Further, a small number of sculpted relief fragments have been recovered that may or may not belong; but these are insufficient in number and size to permit even the most tentative reconstruction.

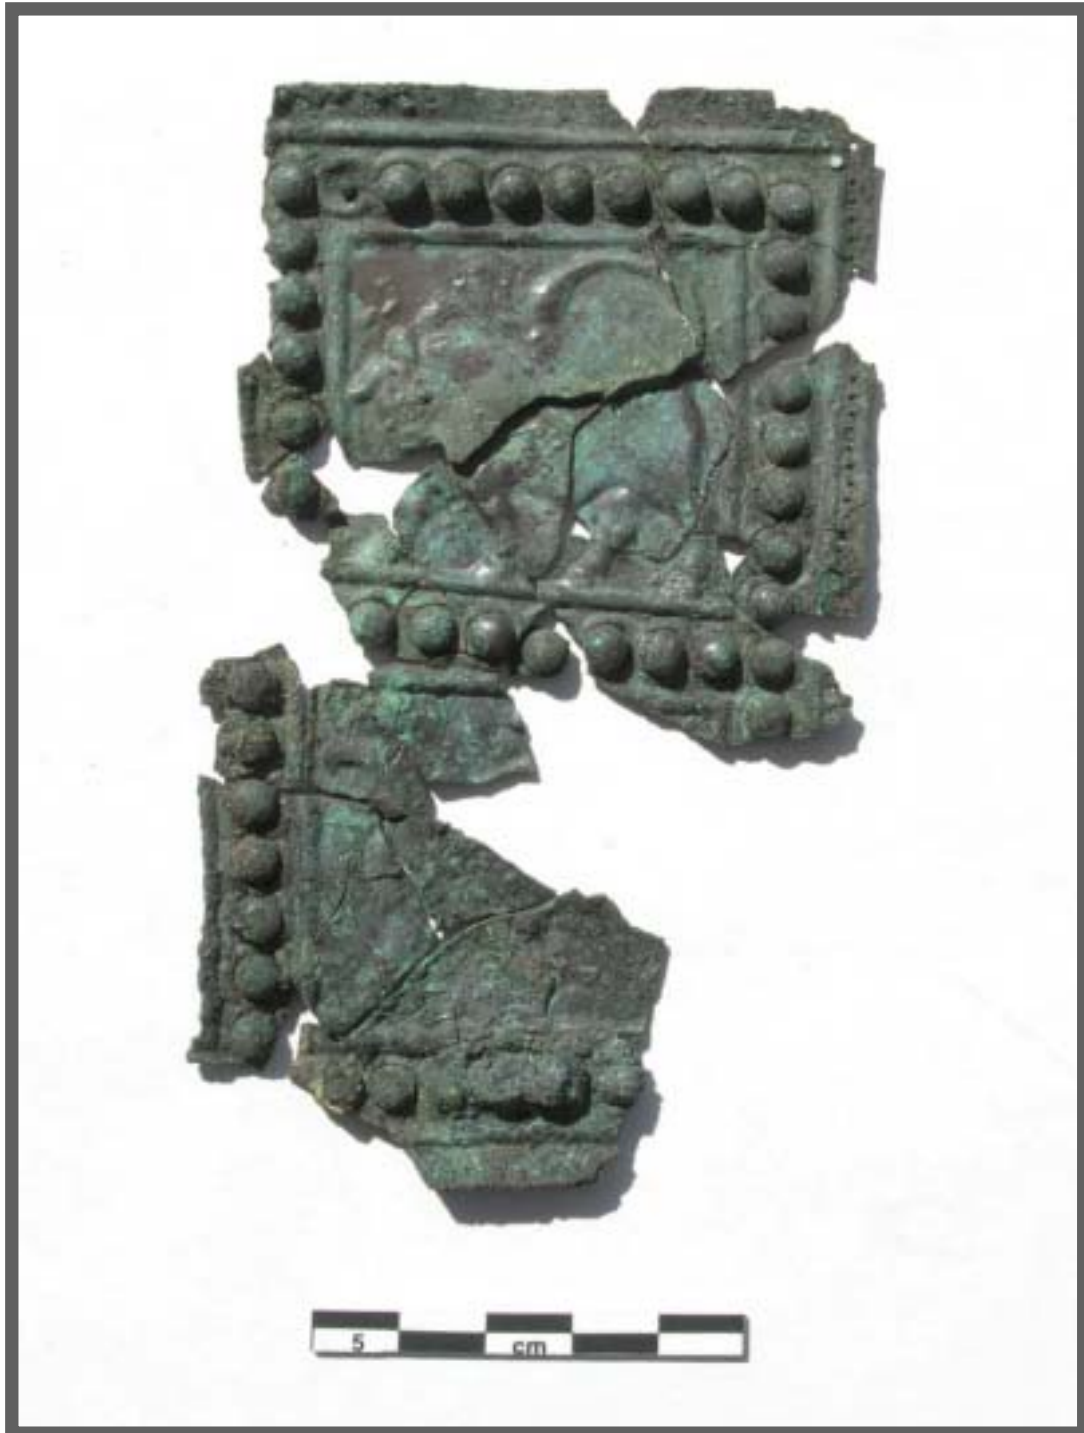
*Figure 52. The bronze sheet, K05.204 with ID 05TR17U14met01, depicting a bull and a griffin is incomplete. It is divided into panels surrounded by attached bosses and sewing holes on top and right edge. (05dpnc1926)*

An incomplete length of sheet bronze (K05.204 with ID 05TR17U14met01), has embossed and stamped decoration in the form of two square panels, one above the other. The top panel contains a bull while that below has a griffin, both facing left (Fig. 52). Added domes border the panels. There are small sewing holes along the top and right edges.

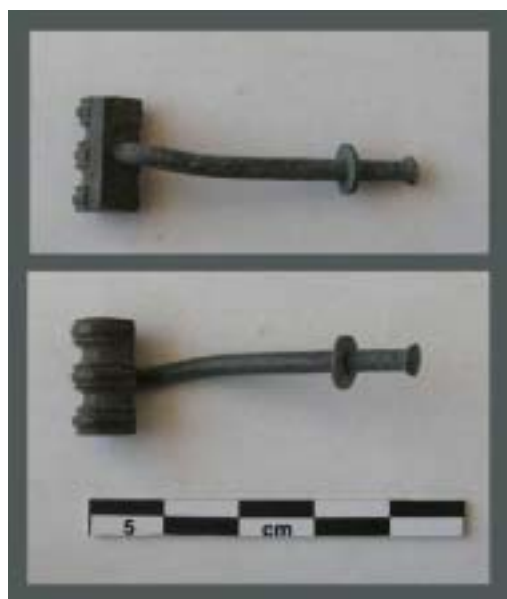
*Figure 53. A bronze fitting, K05.203 with ID 05TR17U12met01. (05dpnc1548)*

A cast bronze fitting (K05.203 with ID 05TR17U12met01), perhaps from a bowl, is remarkably well preserved (Fig. 53).

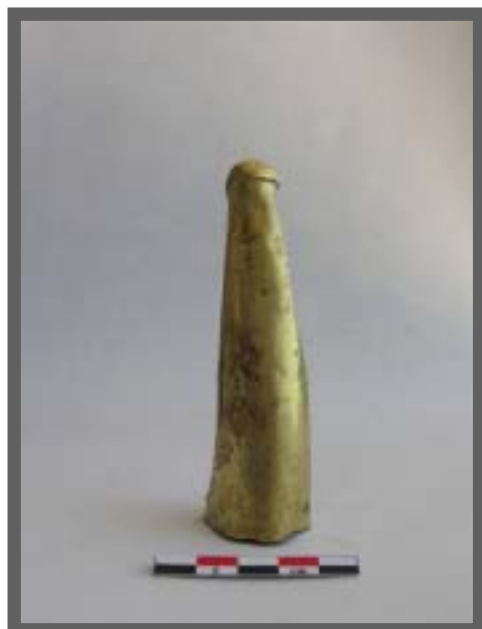
*Figure 54. Horn, gold sheet, K05.215 with ID 05TR16U16met05, hollow with traces of wood surviving. (05dpnc1819)*

A thick piece of gold sheet (K05.215 with ID 05TR16U16met05) was discovered on the pavement immediately in front of the southern column base at the front of the entrance. It was formed round a wooden core to which it was once attached by a single nail, perhaps in the shape of a horn with a knobbed end (Fig. 54). The presence of this precious object might indicate why the later robbing of the entrance was so extensive.

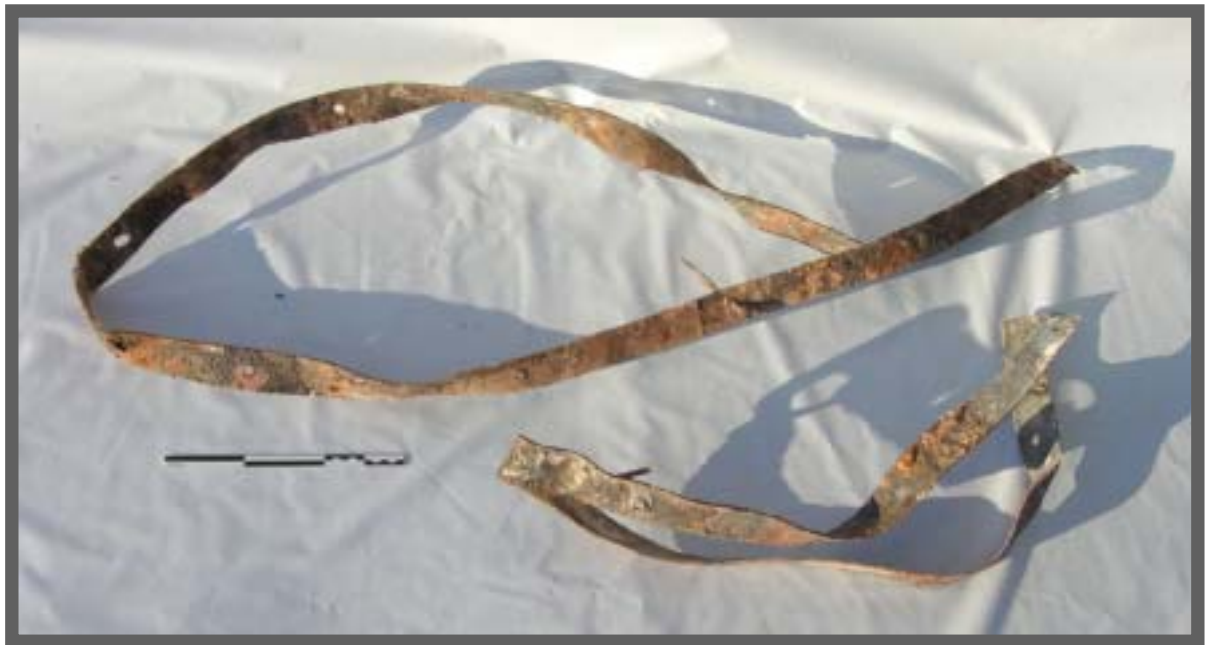
*Figure 55. Two iron bands, K05.191 with ID 05TR16U18met05, K05.192 with ID 05TR16U18met06, pierced with some nails still in place, probably from wooden doors. The scale is 30cm. (05dpnc1369)*

Two large iron bands (K05.191 with ID 05TR16U18met05, K05.192 with ID 05TR16U18met06), almost identical to those discovered in 2002, were found against the tower wall on the south side of the passage. Fragments of similar bands were also recovered from the inner end of the entrance, although these were less well preserved than the complete bands from the front which are still tensile to this day. Some of the holes punched through these bands still contained large dome-headed nails (Figs 55 and 56) while fugitive nails were found in the burnt debris nearby. It is thought that these derived from the doors, their being two horizontal bands on each. The dimensions are not inconsistent with this interpretation and the find spots lend further support the conclusion that the doors had been taken down before the fire, perhaps to remove metal embellishment and to loot out metal door sockets.

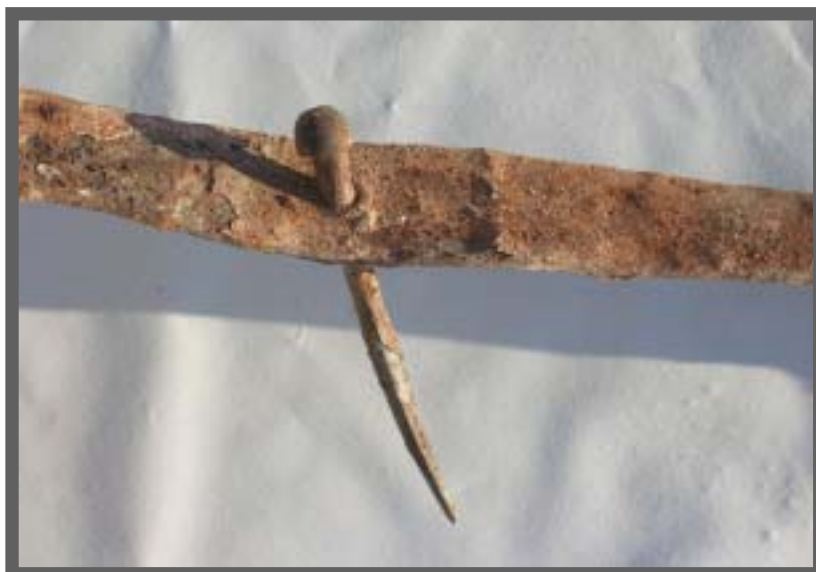
*Figure 56. Close up of hole and nail. (05dpnc1375)*

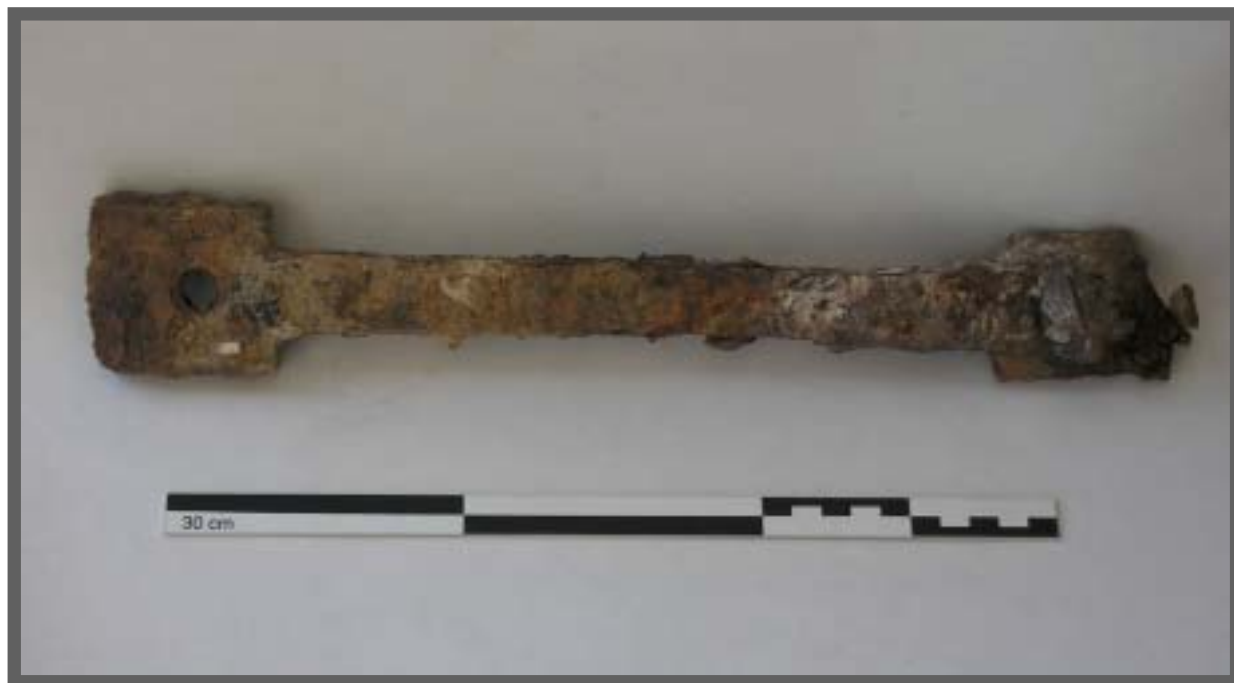
*Figure 57. Iron brace, K05.207 with ID 05TR17U14met07. (05dpnc1541)*

A second large iron brace (K05.207 with ID 05TR17U14met07) found in 2005 near the South Tower is very similar to the one found in 2002 by the North Tower and amplifies the architectural symmetry of the entrance. The brace (Fig. 57) has squared ends and large dome-headed nails.

In addition, a number of smaller braces with splayed ends and smaller nails paralleled those found in the two previous seasons. Like the bands described above, these iron braces are witness to the structural importance of iron in strengthening timber construction.

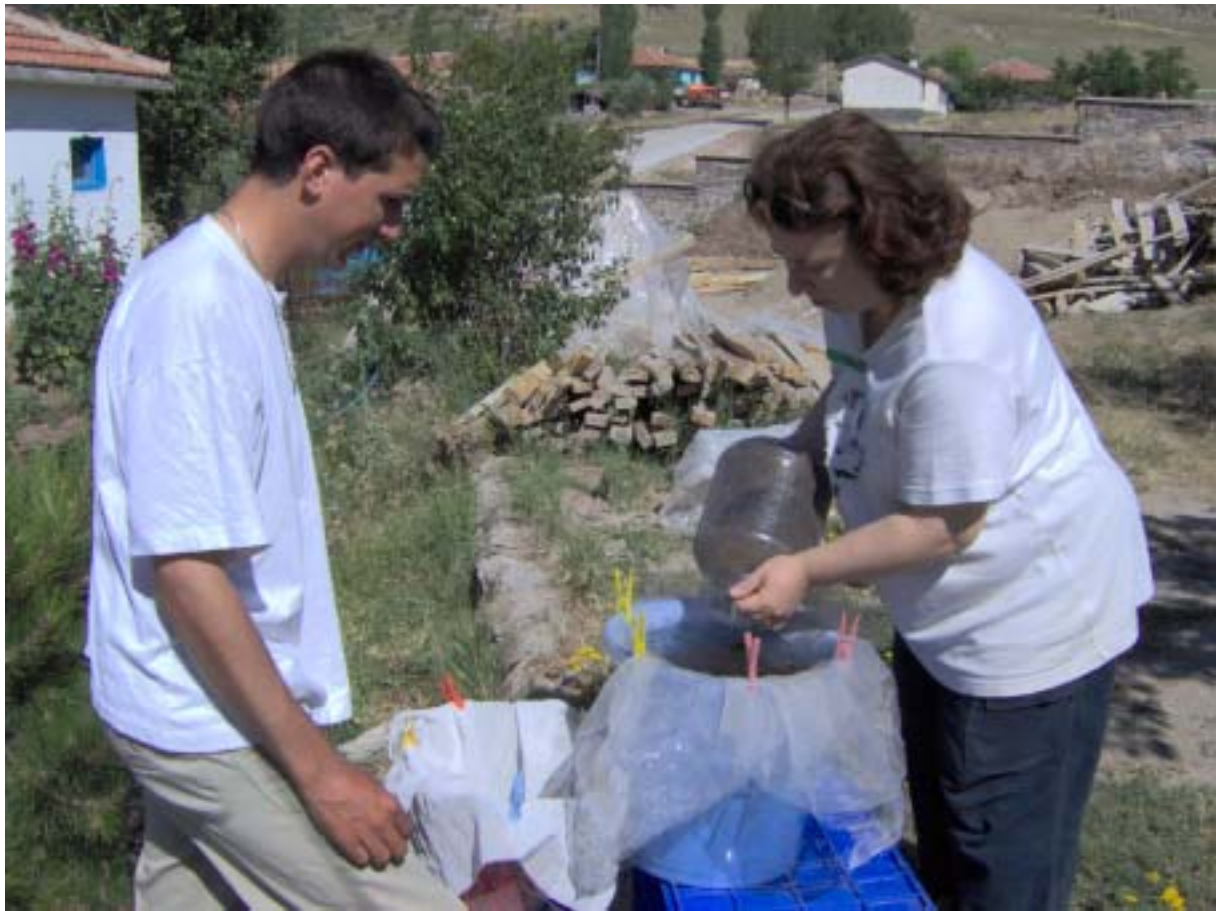
*Figure 58. Rémi Berthon and Vicky Ioannidou experiment with flotation. (05dphp1606)*

The animal bone is generally in poor condition which, combined with the hardness of the soil when dry, made recovery of easily measurable fragments both difficult and time-consuming. It was concluded that wetting the soil before excavation makes bone extraction easier with very significantly less breakage. Experiments with simple floatation, using a series of buckets, produced seeds and charcoal whilst wet sieving the residue permitted the extraction of small bones and bone fragments.
